OFFICE OF THE
DOUGLAS COUNTY SURVEYOR

Station: VALLEY T 27 S, R 6W, Sec 28
Set By (Agency): DCSO
Date Set: 1989
Recovered By RWS, SJF
Date Recovered 6/1/89
Recovered By _____
Date Recovered _____
Recovered By _____
Date Recovered _____

V-029

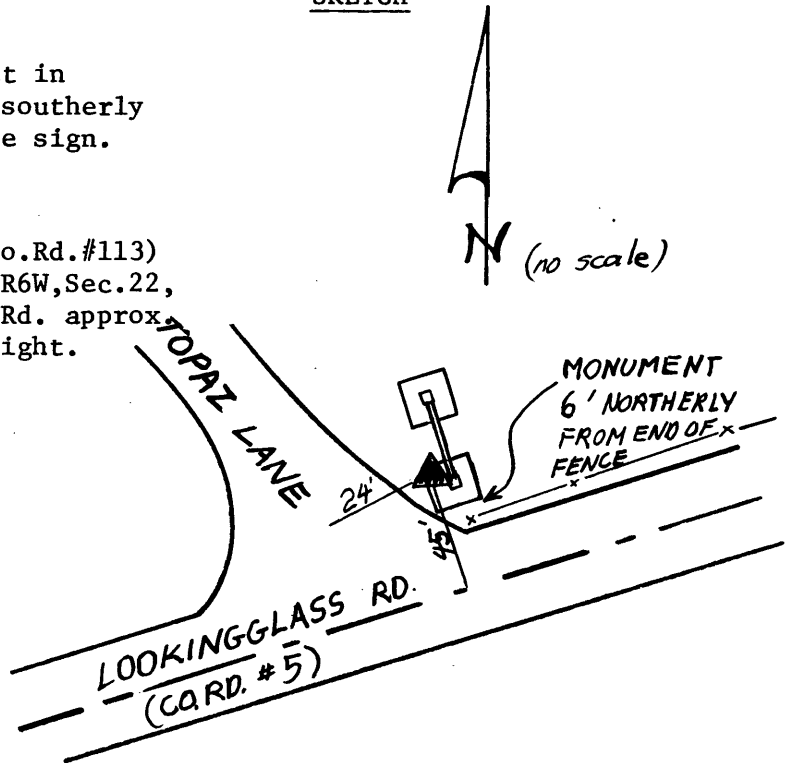
SKETCH

A DCSO drill cap stamped "VALLEY 1989" set in a 4 ft. by 4 ft. concrete pad supporting southerly end of Diamond Valley subdivision entrance sign.

From the intersection of Military ave. (Co.Rd.#113) and Lookingglass Rd. (Co.Rd.#5D) in T27S,R6W,Sec.22, proceed southwesterly along Lookingglass Rd. approx. 0.9 miles to Topaz lane and monument on right.
