OFFICE OF THE
DOUGLAS COUNTY SURVEYOR

W-066

Station: WESTWOOD

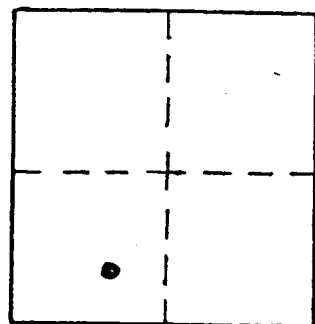
A ~~1/2" DIAMETER~~ DCSO DRILL CAP STAMP
"WESTWOOD 1998" SET FLUSH IN LEDGE OF EXPOSED
BEDROCK CUT-BANK APPROXIMATELY 3 FEET ABOVE ROAD
SURFACE.

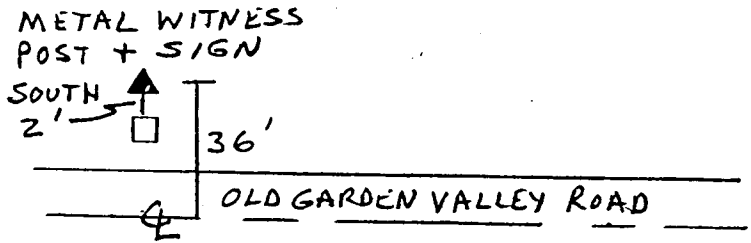
FROM THE INTERSECTION GARDEN VALLEY ROAD (CO RD #6)
AND OLD GARDEN VALLEY RD. (CO. RD. # 6A) IN T26S, R66W,
SEC. 28 PROCEED WESTERLY ALONG OLD GARDEN VALLEY
RD. APPROXIMATELY 0.45 MILES TO MONUMENT ON RIGHT.
