OFFICE OF THE
DOUGLAS COUNTY SURVEYOR

Station: X-032

T 27 S, R 2W , Sec 9

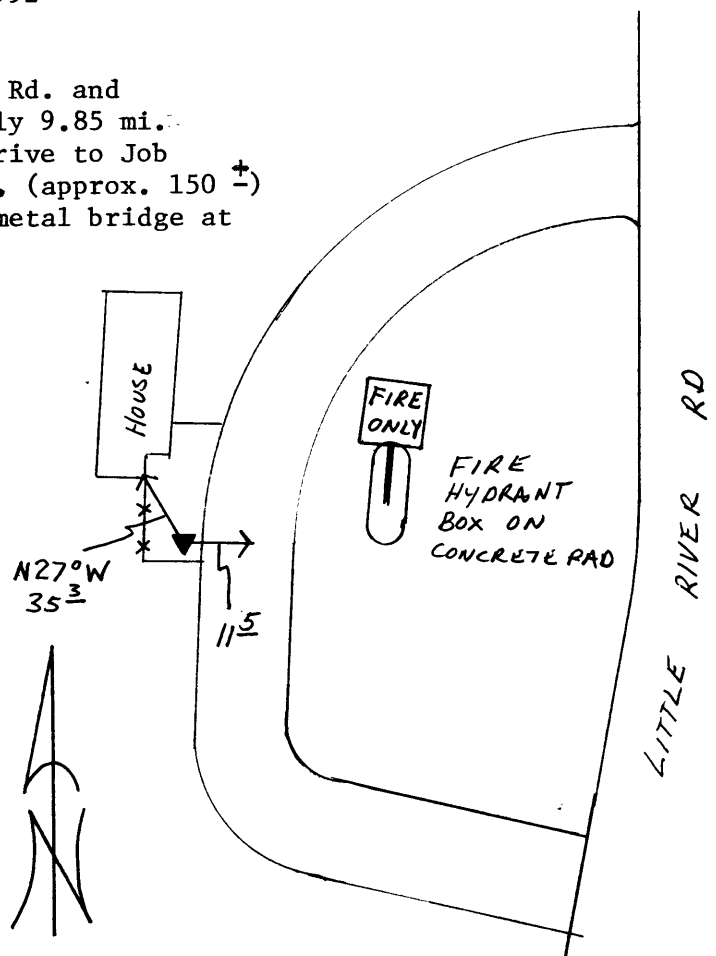
SKETCH

Set: A standard DCSO disk stamped "X-032 1992"
set in a concrete driveway.

To Reach: From the intersection of Buckhorn Rd. and
Litter River Rd. proceed N'Easterly 9.85 mi.
(MP 21.35) to intersection with drive to Job
Corp housing which is the 1st. Rd. (approx. 150 ±)
to the left beyond arched green metal bridge at
Wolf Creek Trailhead. See sketch.
