DCSO Designation: X-041

SET: A standard DCSO disk stamped
"X-041 1992" set in a concrete
bridge abutment.

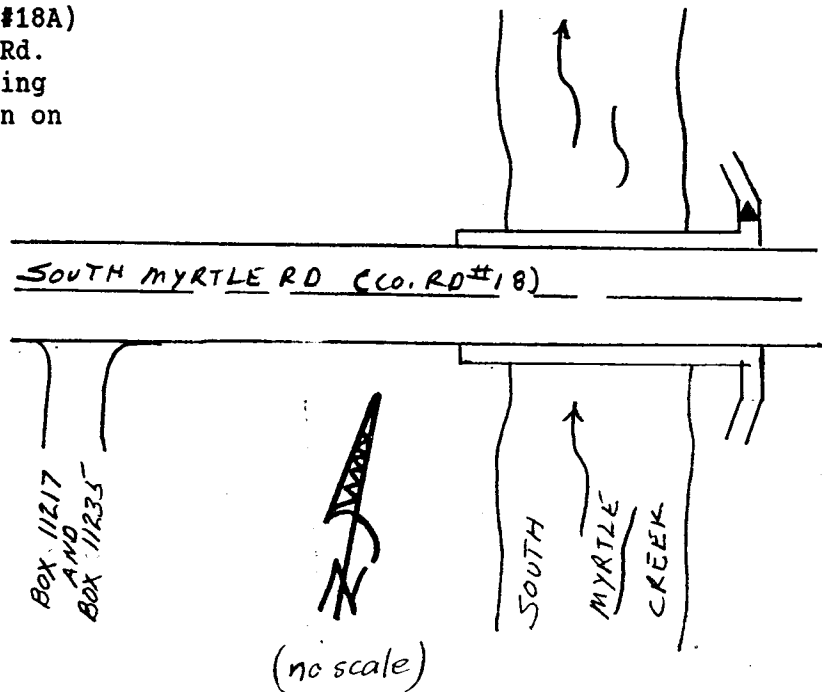
TO REACH: From the intersection of
South Myrtle Rd. (Co.Rd.#18)
and Riverside Dr. (Co.Rd.#18A)
continue on South Myrtle Rd.
to MP 10.7 a bridge crossing
South Myrtle Creek and mon on
the left.
