DOUGLAS COUNTY SURVEYOR'S OFFICE

Designation: Z-019 Station: ZEBULON T ZIS R 11W S 20 ¼ SE

DESCRIPTION AND TO REACH

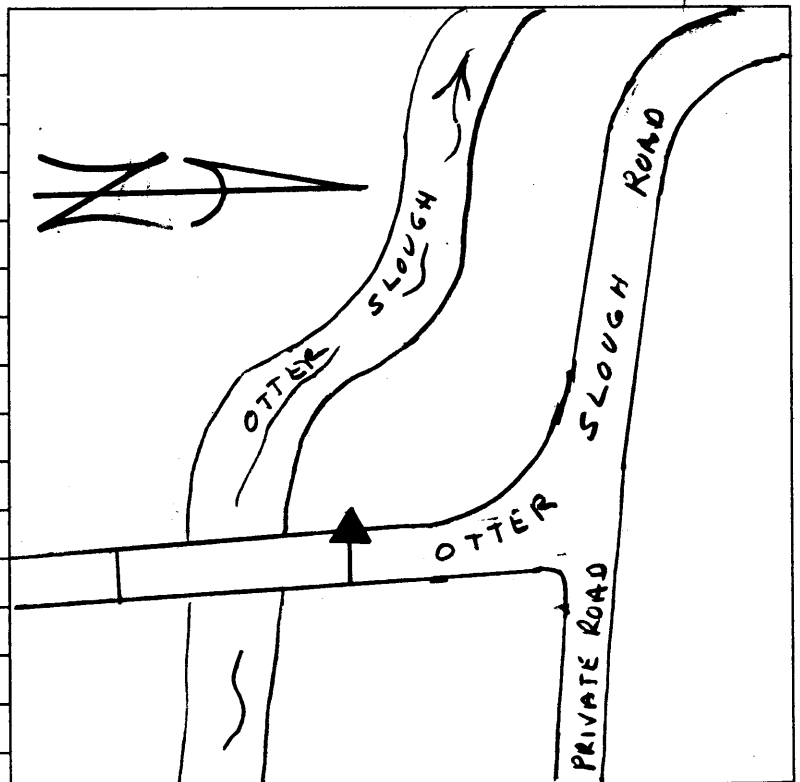
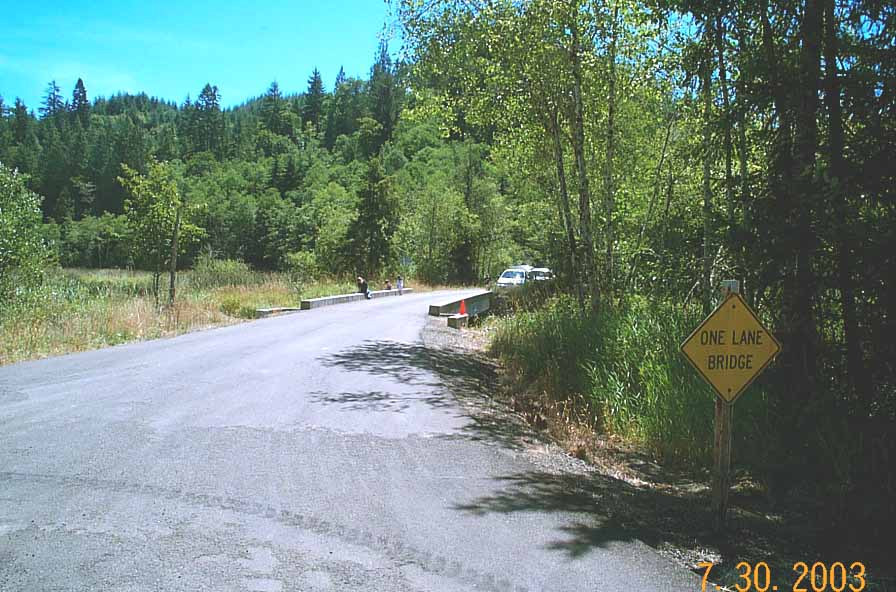
DCSO DRILL CAP STAMPED
'ZEBULON 2003' SET IN
NORTH WEST WING WALL OF
CONCRETE BRIDGE OVER
OTTER CREEK

FROM THE INTERSECTION OF
SOUTH SMITH RIVER RD. (CO. RD #195)
AND OTTER SLOUGH RD (CO. RD
#119) PROCEED SOUTH EASTERLY
ALONG OTTER SLOUGH ROAD
0.65 MILES TO CONCRETE
BRIDGE OVER OTTER CREEK
