OFFICE OF THE
DOUGLAS COUNTY SURVEYOR

Station: EVE T 22 S, R 4 W, Sec 31
 Set By (Agency): DCSO
 Date Set: 1978
 Recovered By RWS, S.J.F.
 Date Recovered 9/87 (FDOR 1991)
 Recovered By _____
 Date Recovered _____
 Recovered By _____
 Date Recovered _____

#-025 22S 4W 31
EVE

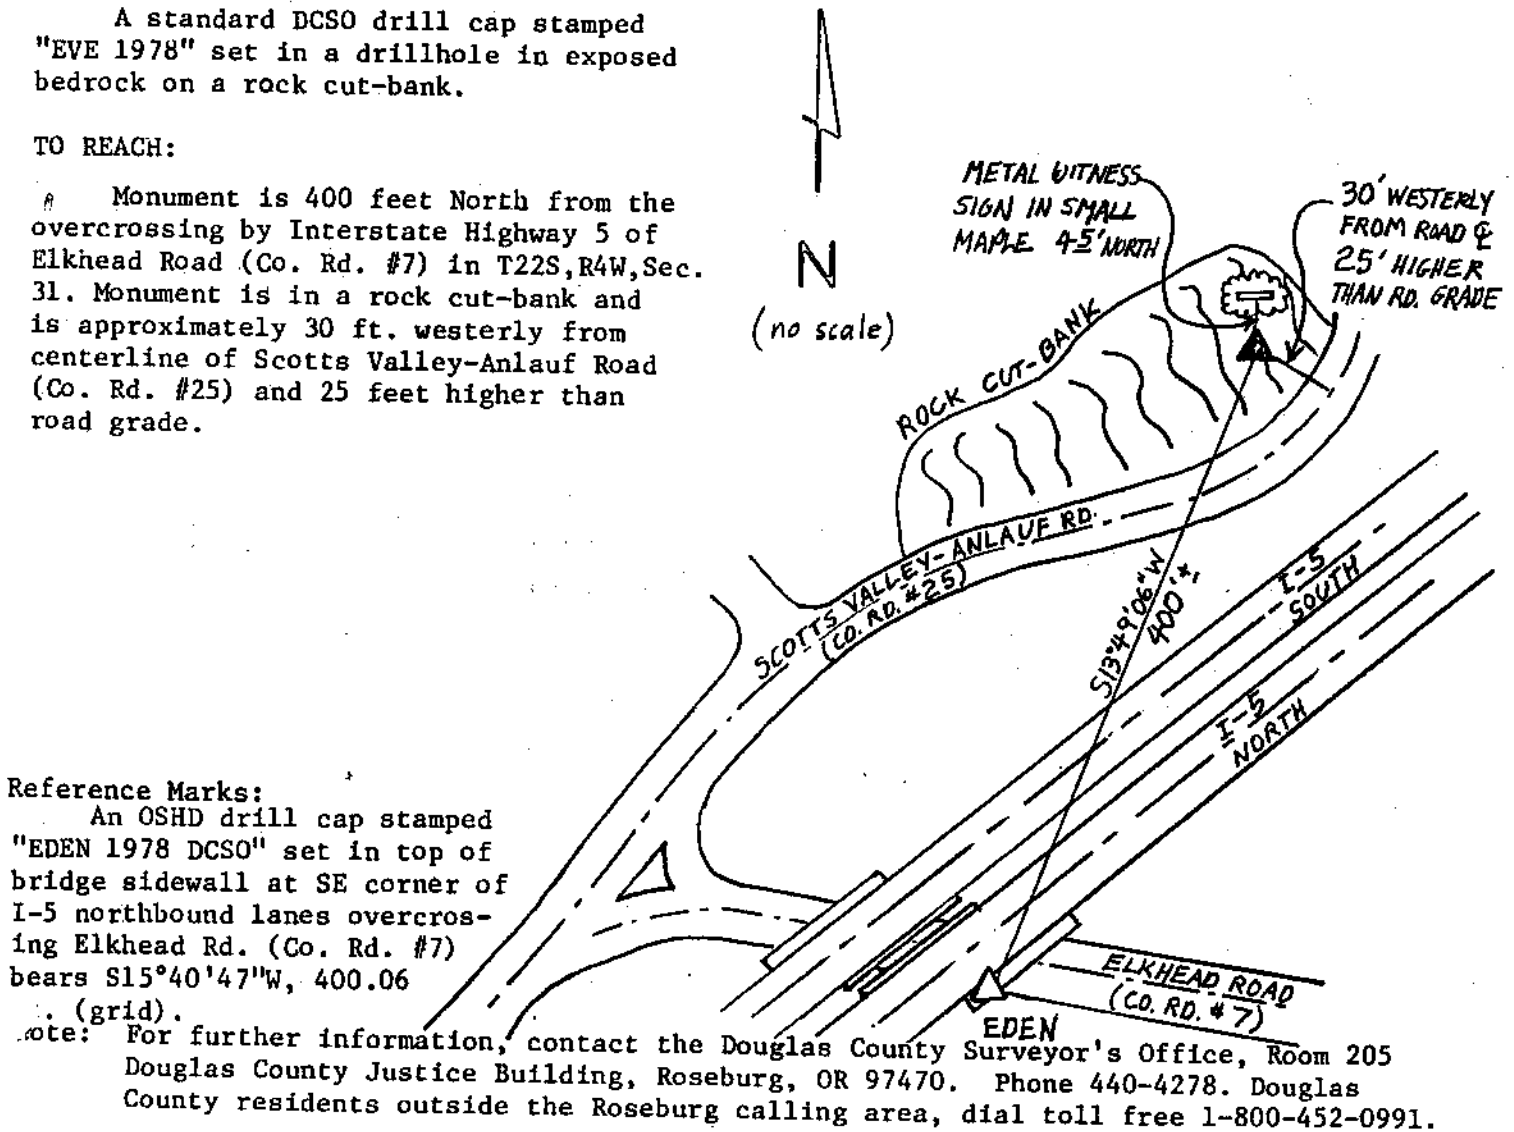
SKETCH

Monument is 400 feet North from the overcrossing by Interstate Highway 5 of Elkhead Road (Co. Rd. #7) in T22S, R4W, Sec. 31. Monument is in a rock cut-bank and is approximately 30 ft. westerly from centerline of Scotts Valley-Anlauf Road (Co. Rd. #25) and 25 feet higher than road grade.

An OSHD drill cap stamped "EDEN 1978 DCSO" set in top of bridge sidewall at SE corner of I-5 northbound lanes overcrossing Elkhead Rd. (Co. Rd. #7) bears S15°40'47"W, 400.06 (grid).
