OFFICE OF THE
DOUGLAS COUNTY SURVEYOR

Station: U64 U065 T 22 S, R 8 W, Sec 20

DESCRIPTION and TO REACH

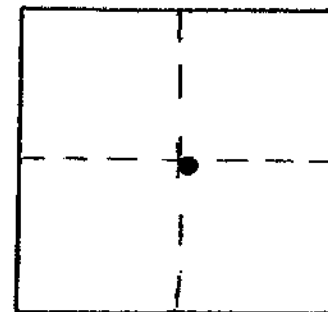
SKETCH

A DCSO drill cap stamped "U64 1972" set flush in a 1 1/2' X 3' boulder protruding 0.5 ft. from ground in road drainage ditch.

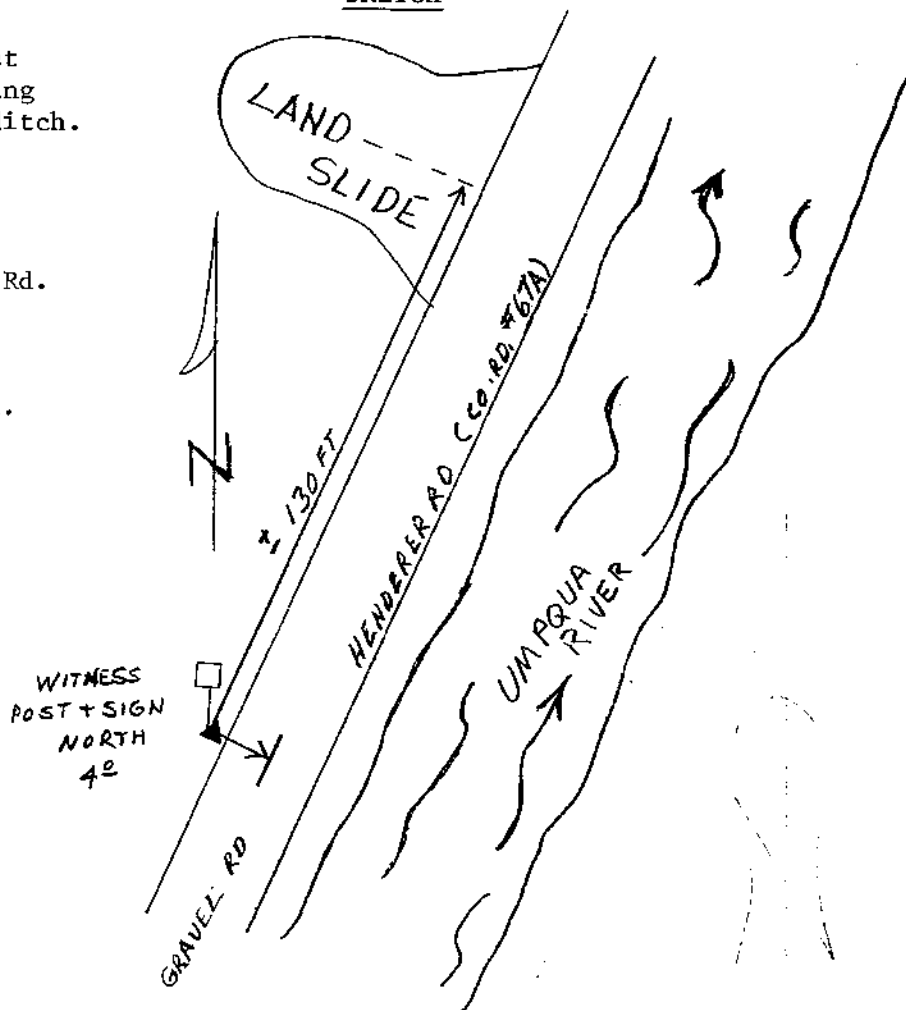
From the intersection of Hedden Ridge Rd. (BLM Rd. #22-8-29.0) and Henderer Rd. (Co. Rd. #118) in T22S, R8W, Sec. 29, proceed northerly along Henderer Rd. approx. 0.55 miles to monument on left.
