Station: HEN-7
Date Set: 1998
Set By (Agency): DCSO
Date Recovered: 7-28-98
Recovered By: RWS SJF

H-076

VERTICAL CONTROL

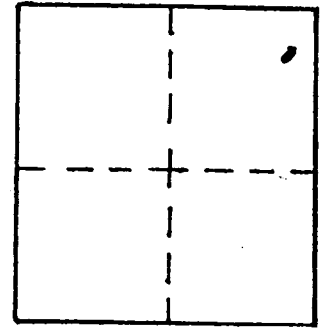
2 3/4" DIA DCSO DRILL CAP STAMPED "HEN-7 1998"
IS SET IN THE "SOUTH EAST" ABUTMENT OF
A CONCRETE BRIDGE OVER A SMALL CREEK

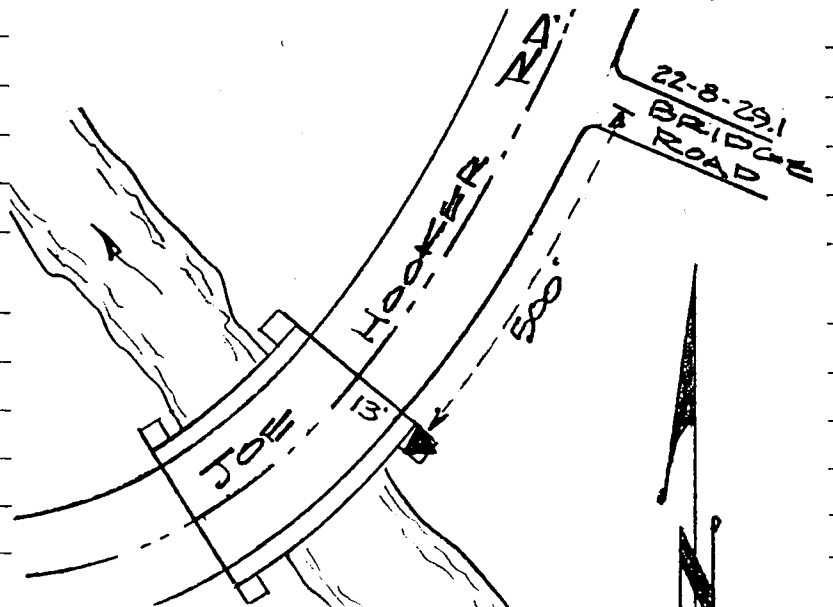
FROM THE INTERSECTION OF MILL CREEK RD
(CO. RD #11) AND HENDERER ROAD (CO. RD #118)
IN T22S R8W SEC 30, PROCEED NORTHWESTERLY
ALONG HENDERER ROAD 5.40 TO HENDERER ROAD
(CO. RD #67A AND BRIDGE ROAD (22-8-29.1))
PROCEED WESTERLY ALONG HENDERER ROAD 500 FT
TO CONCRETE BRIDGE AND MONUMENT ON LEFT.
