OFFICE OF THE  
DOUGLAS COUNTY SURVEYOR

Station: CILLA T 23 S, R 5 W, Sec 10  
Set By (Agency): DCSO  
Date Set: 1974  
Recovered By RWS,SJF  
Date Recovered 9/11/87  
Recovered By \_\_\_\_\_  
Date Recovered \_\_\_\_\_  
Recovered By \_\_\_\_\_  
Date Recovered \_\_\_\_\_

23S 5W 10

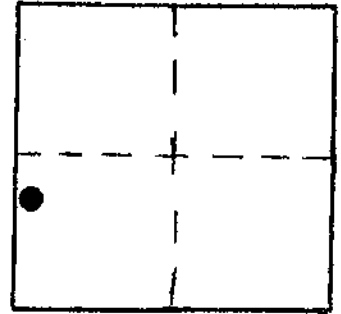
A DCSO disk stamped "CILLA 1974" set in  
an 8 in. dia. concrete filled belltile  
protruding 4 in. above ground.

Go to the intersection of Rice Valley Rd.  
(Co.Rd.#30) and Wilson Rd. (Co.Rd.#127)  
in T23S,R5W,Sec.10, monument is northwest  
of intersection.

WIT POST  
+ SIGN  
2 FT WEST

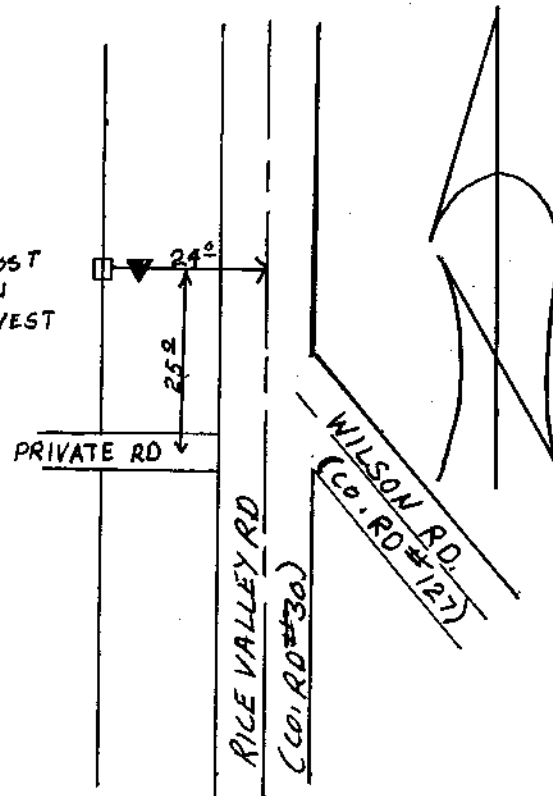
SKETCH

A DCSO disk stamped " Cilla RM 1 1978"  
bears N 61°53'34"E, 65.15 ft. (grid)

A DCSO disk stamped " Cilla RM 2 1978"  
bears S 0°48'29"E, 429.50 ft. (grid).
