OFFICE OF THE
DOUGLAS COUNTY SURVEYOR

Station: U-18
 Date Set: 1972
 Set By (Agency): DCSO
 DCSO Designation: U-019
 Date Recovered: 11-17-93
 Recovered By: RWS SJF
 Date Recovered: _____
 Recovered By: _____
 Date Recovered: _____
 Recovered By: _____

T24W R7W Sec. 20

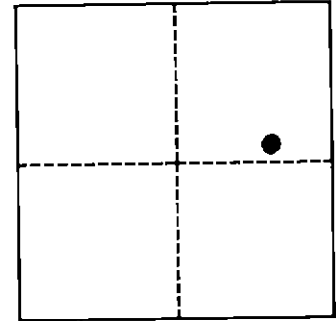
Description: A brass stem near the center of a 8'x6'x6' boulder. The brass cap has been removed.

To reach: From the intersection of state Hwy 138 and Tyee Rd. (Co. Rd. #33) in T24S R7W Sec13 proceed southwesterly along Tyee Rd. 5.2 miles to monument on left.
