OFFICE OF THE  
DOUGLAS COUNTY SURVEYOR

6-028  
TERESA

Station: TERESA  
Set By (Agency): DCSO  
Date Set: 1980  
Recovered By RWS, SJF  
Date Recovered July 3, 1985  
Recovered By \_\_\_\_\_  
Date Recovered \_\_\_\_\_  
Recovered By \_\_\_\_\_  
Date Recovered \_\_\_\_\_

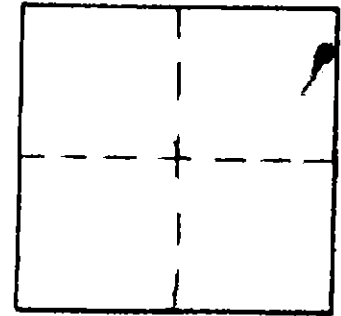
SKETCH

A drilled hole in concrete with a brass stem 1/2 inch below overcrossing surface (brass cap broken off).

Go to the I-5 overcrossing of Stearns Lane (Co. Rd. #10A) in T25S, R5W, Sec. 7.  
Monument lies in southwest corner of structure.

MONUMENT 0 1/2 FT EAST OF  
CONCRETE CURB  
18 1/2 FT. TO END  
OF CONCRETE STRUCTURE

22° FT. TO E OF  
SOUTHBOUND LANES
