OFFICE OF THE
DOUGLAS COUNTY SURVEYOR

M-065
MILLER

25S 5W 20

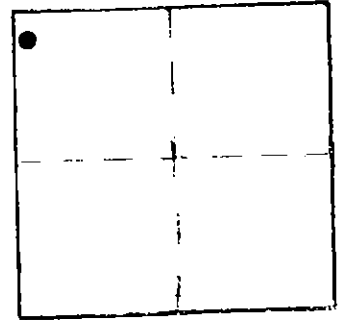
SKETCH

A DCSO drill cap stamped "MILLER 1989"
set in top of concrete curb on south
side of Central avenue.

Go to the intersection of Miller St.
and Central Avenue in T25S,R5W,Sec.20,
at Sutherlin, monument is 36 ft. easterly
of intersection.
