OFFICE OF THE
DOUGLAS COUNTY SURVEYOR

Station: SILLY
 Set By (Agency): DCSO
 Date Set: 1980
 Recovered By LEM
 Date Recovered 1981
 Recovered By _____
 Date Recovered _____
 Recovered By _____
 Date Recovered _____

T 25 S, R 6W, Sec 12

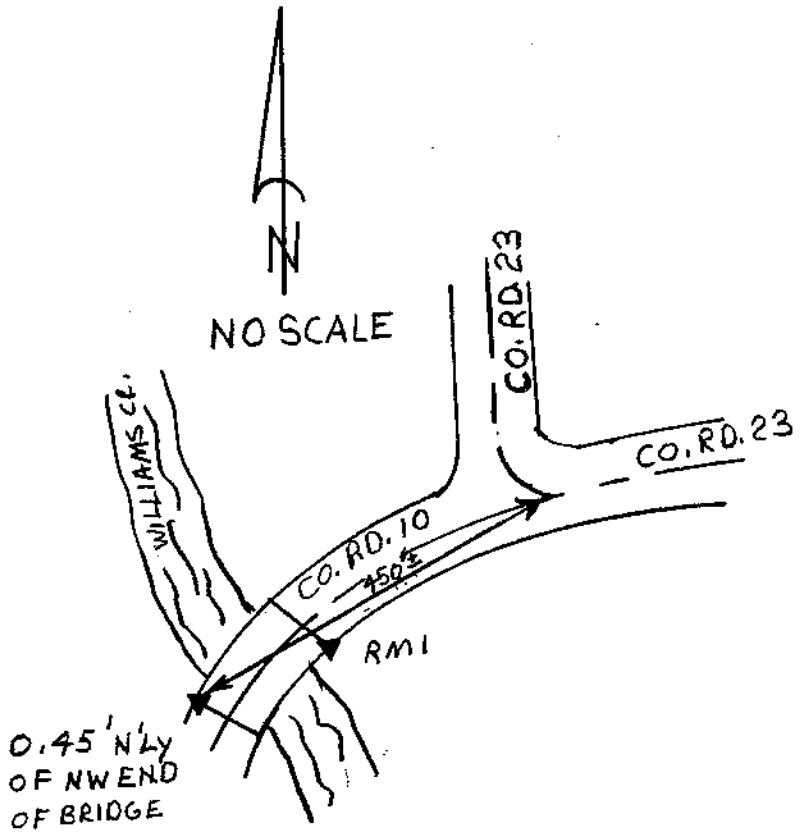
SKETCH

A standard DCSO disk stamped "SILLY 1980" set in northwesterly corner of bridge.

From the intersection of Co. Rd. 10 (old Hwy.225) and Co. Rd. 23 (Green Valley Rd.) in T25S, R6W, Sec.12; proceed westerly along Co. Rd. 10 approx. 450 ft. to monument on right.

A standard DCSO disk stamped "SILLY RMI 1980" set 0.32 ft. from the SE'LY end of bridge in bridge curbing bears N 61° 13' 54" E 79.37 ft. (grid), 2nd-1 elev. is 400.540.
