Station: HUBBA-11

T 25 S, R 8W, Sec 36

DESCRIPTION and TO REACH

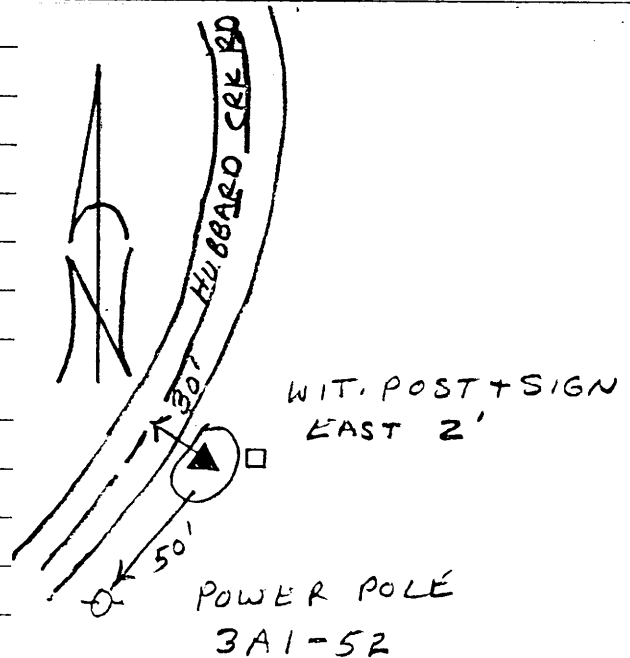
Reference Marks:

DCSO DRILL CAP STAMPED "HUBBA-11 2000" SET IN
A 3'x2' ROCK THAT IS FLUSH WITH GROUND.
