OFFICE OF THE
DOUGLAS COUNTY SURVEYOR

B-119

Station: BUNTON T 26 S, R 5 W, Sec 7
Set By (Agency): DCSO
Date Set: 1989
Recovered By RWS, SJF
Date Recovered 5/9/89
Recovered By _____
Date Recovered _____
Recovered By _____
Date Recovered _____

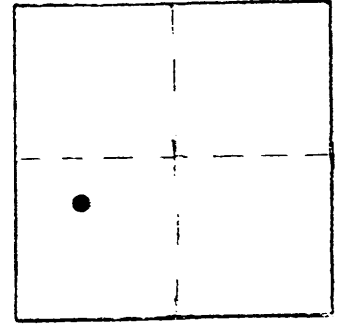
A DCSO drillcap stamped "BUNTON 1989" set in top of northeast wingwall of bridge abutment.

From the intersection of Old Highway 99 (Co.Rd.#388) and Oak Hill Rd. (Co.Rd.#32) in T26S,R5W,Sec.7, proceed westerly along Oak Hill Rd. approx. 100 ft. to bridge over Sutherlin Creek, and monument at north east corner.
