OFFICE OF THE  
DOUGLAS COUNTY SURVEYOR

Station: NU 3 T 26 S, R 6 W, Sec 28

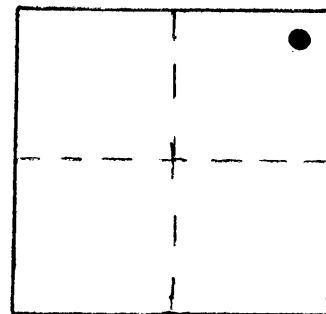
A DCSO disk stamped "NU 3 1972"  
set in a boulder flush with ground.

Go to the intersection  
of Garden Valley Rd.  
(Co. Rd. #31A) and  
Del Rio Rd.  
(Co. Rd. #31C) in T26S, R6W,  
Sec. 28. Monument lies on  
north edge of intersection.

A standard DCSO disk stamped "NU 3 1972  
RM 1 1979" set in an 8 inch o.d. concrete  
filled bell tile set flush with ground, bears  
N10°02'13"E, 46.25 ft. distant (grid).

A standard DCSO disk stamped "NU 3 1972 RM 2 1979" set in an 8 inch o.d. concrete  
filled bell tile set flush with ground, bears S47°10'12"E, 184.58 ft. distant (grid).
