OFFICE OF THE  
DOUGLAS COUNTY SURVEYOR

Station: IMAGE T 27 S, R 2 W , Sec 3  
Set By (Agency): DCSO  
Date Set: 1981  
Recovered By \_\_\_\_\_  
Date Recovered \_\_\_\_\_  
Recovered By \_\_\_\_\_  
Date Recovered \_\_\_\_\_  
Recovered By \_\_\_\_\_  
Date Recovered \_\_\_\_\_

1-004  
IMAGE

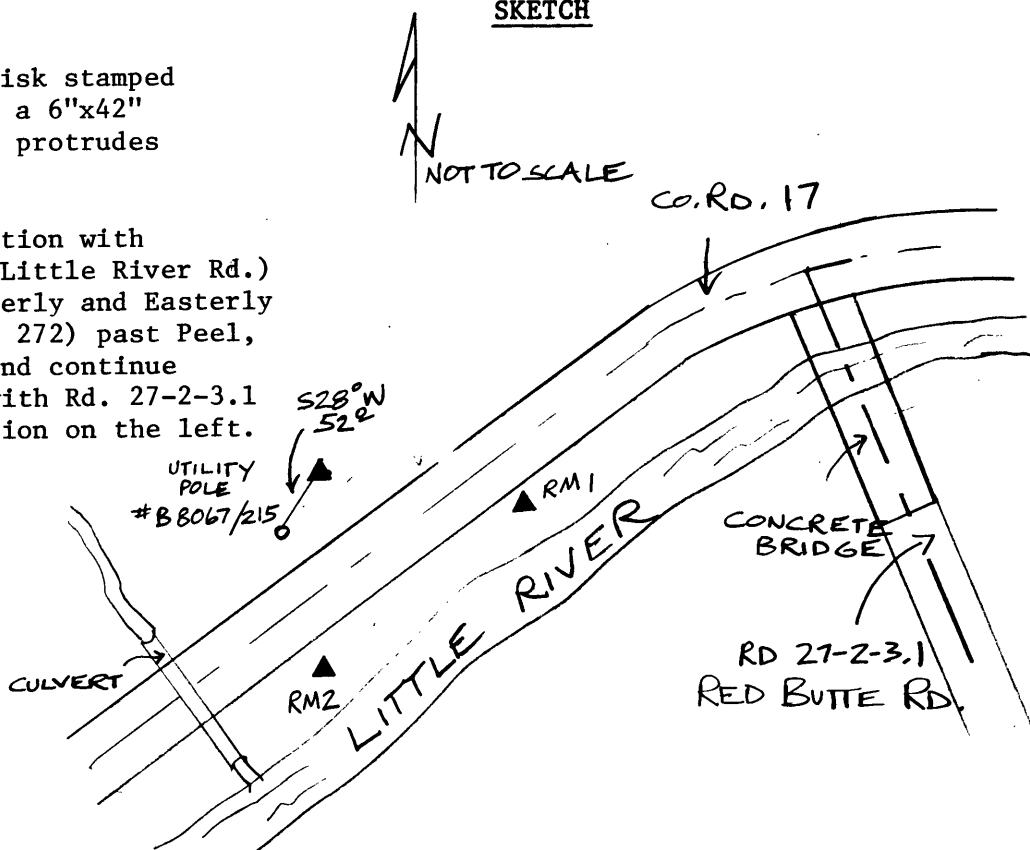
SKETCH

Station is a standard DCSO disk stamped "IMAGE 1981". Disk is set in a 6"x42" concrete filled belltile and protrudes 2" from the ground.

"IMAGE RM 1 1981" is a standard DCSO disk in concrete filled belltile, protruding 6" above the ground bears S83°00'22"E 59.75 ft. (grid) from the station.

"IMAGE RM 2 1981" is a standard DCSO disk set in concrete filled belltile, protruding 4" above the ground bears S 0°32'57"W 98.77 ft. (grid) from the station.

To Reach: From the intersection with St. Hwy 138 and Co. Rd. 17 (Little River Rd.) west of Glide, proceed Southerly and Easterly on Co. Rd. 17 (it becomes FS 272) past Peel, and the Wolf Cr. Job Corps and continue almost to its intersection with Rd. 27-2-3.1 (Red Butte Rd.) and the station on the left.
