OFFICE OF THE
DOUGLAS COUNTY SURVEYOR

Station: CYNTHIA T 27 S, R 5 W, Sec 19

c-124
CYNTHIA

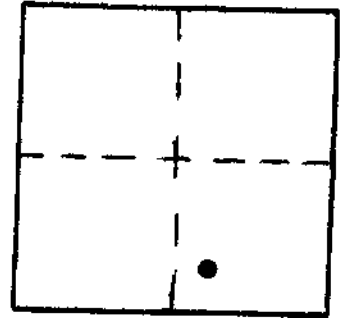
SKETCH

A DCSO disk stamped "CYNTHIA 1982"
set flush in concrete curbing.

From the intersection of SE Terrace Dr.
and SE Summit Dr. proceed westerly
along SE Terrace Dr. 0.12 miles to
monument on right.
