OFFICE OF THE  
DOUGLAS COUNTY SURVEYOR

Station: VIRGINIA T 27 S, R 6 E , Sec 32  
Set By (Agency): DCSO  
Date Set: 1974  
Recovered By FLI (DCSO)  
Date Recovered 6-28-84  
Recovered By \_\_\_\_\_  
Date Recovered \_\_\_\_\_  
Recovered By \_\_\_\_\_  
Date Recovered \_\_\_\_\_

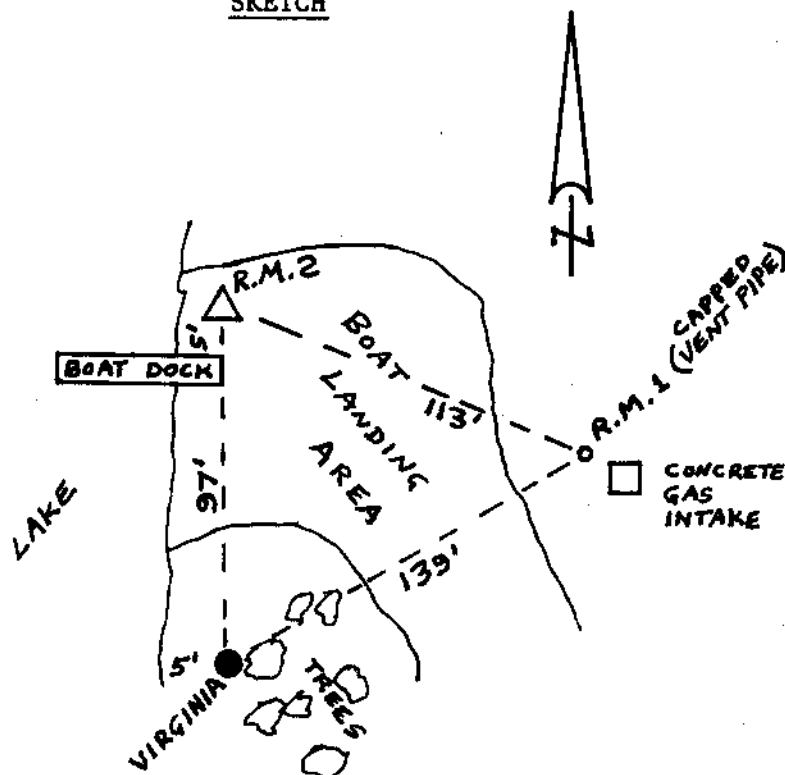
SKETCH

Near boat ramp just south  
of Diamond Lake Lodge.

Stem of brass cap in 2 ft.  
diameter boulder under a bush,  
40 ft. south of boat ramp, 5 ft.  
east of water.

| Reference Marks: | VIRGINIA R.M. 1 | Center of vent pipe west of concrete gas intake (El. 5193.905) |
| | VIRGINIA R.M. 2 | Brass cap in 2 ft. diameter boulder (El. 5184.790) |
