OFFICE OF THE  
DOUGLAS COUNTY SURVEYOR

Station: NANDY  
Date Set: 1989  
Set By (Agency): DCSO  
Date Recovered: 6/29/89  
Recovered By: RWS,SJF  
Date Recovered: \_\_\_\_\_  
Recovered By: \_\_\_\_\_  
Date Recovered: \_\_\_\_\_  
Recovered By: \_\_\_\_\_

T 27 S, R 7 W , Sec 25

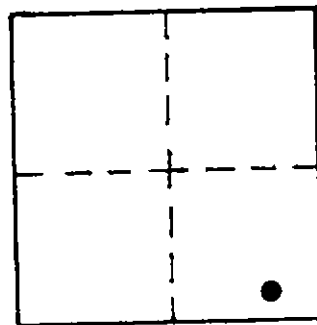
A DCSO drill cap stamped "NANDY 1990" set in northwest corner of bridge over small creek.

Go to the intersection of Nandy Dr. (Co.Rd.#336) and Lookingglass Rd. (Co.Rd.#5D) in T27S,R7W, Sec.25, proceed northeasterly along Lookingglass Rd. approx. 0.25 miles to bridge and monument in northwest corner.
