OFFICE OF THE
DOUGLAS COUNTY SURVEYOR

Station: VIRGINIA

T 27 S, R 6 E, Sec 32

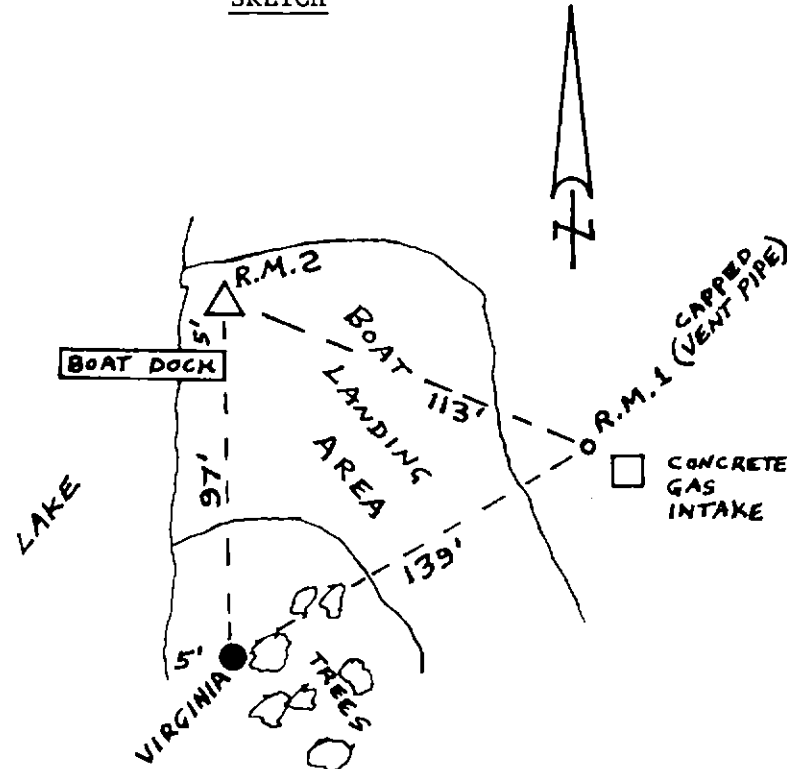
SKETCH

Stem of brass cap in 2 ft. diameter boulder under a bush, 40 ft. south of boat ramp, 5 ft. east of water.

Reference Marks:	VIRGINIA	R.M. 1	Center of vent pipe west of concrete gas intake	(El. 5193.905)
			553,983.04	1,563,454.85
	VIRGINIA	R.M. 2	Brass cap in 2 ft. diameter boulder	(El. 5184.790)
			553,942.38	1,563,350.58
