OFFICE OF THE
DOUGLAS COUNTY SURVEYOR

Station: CARLTON T 27 S, R 7 W, Sec 26

C-140

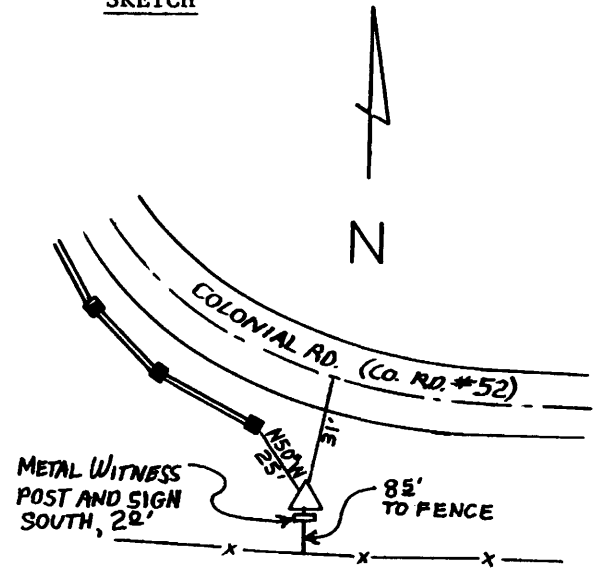
SKETCH

From the intersection of Colonial Rd. (Co.Rd.#32) and the Lookingglass Transfer Rd. (Co.Rd.#317), in T27S,R7W,Sec.26, proceed southwesterly along Colonial Rd. approx. 0.45 miles to monument on right.
