OFFICE OF THE  
DOUGLAS COUNTY SURVEYOR

Station: Robin RM 1

T 28 S, R 4W , Sec 34

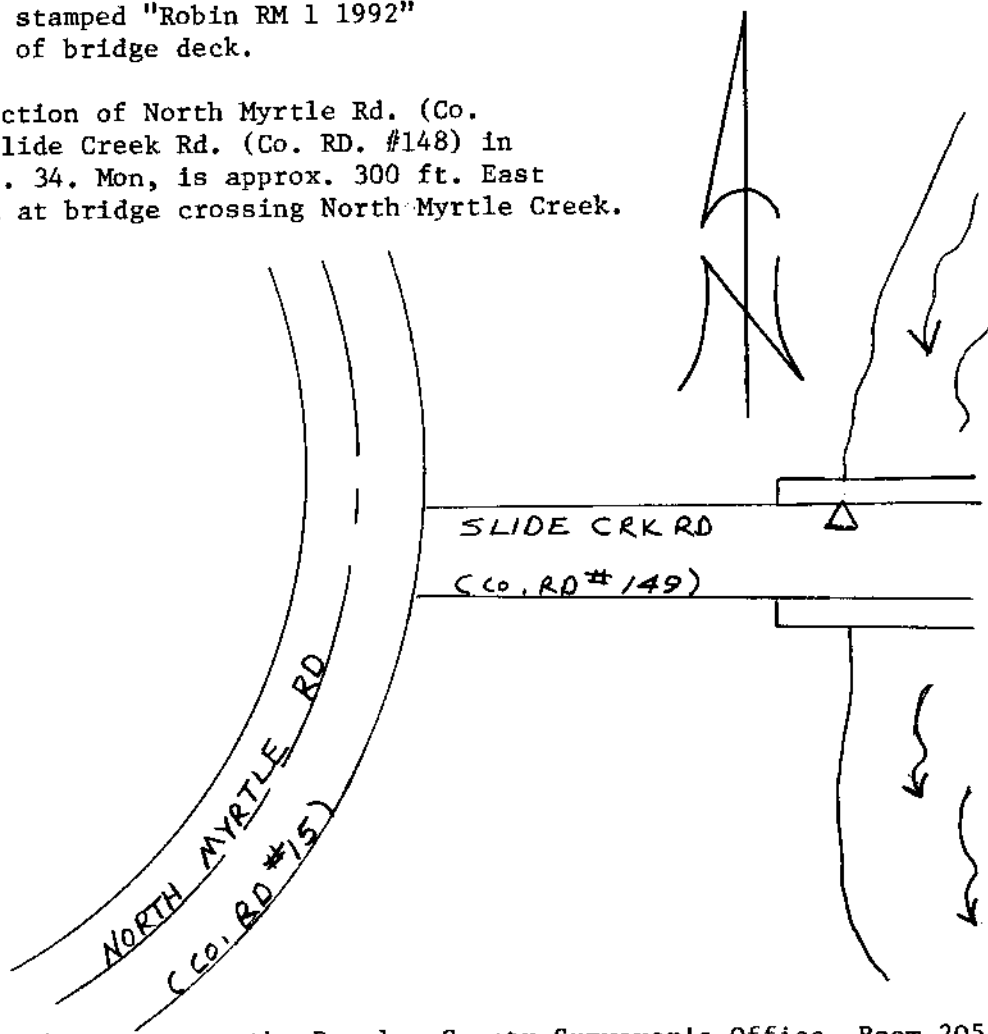
SKETCH

Set: A standard DCSO disk stamped "Robin RM 1 1992"  
set in the NW corner of bridge deck.

To Reach: At the intersection of North Myrtle Rd. (Co.  
Rd. #15; and Slide Creek Rd. (Co. Rd. #148) in  
T28S, R4W, sec. 34. Mon. is approx. 300 ft. East  
on Slide Creek at bridge crossing North Myrtle Creek.
