OFFICE OF THE
DOUGLAS COUNTY SURVEYOR

Station: HUB A T 28 S, R 6 W, Sec 29

n-048
HUB A

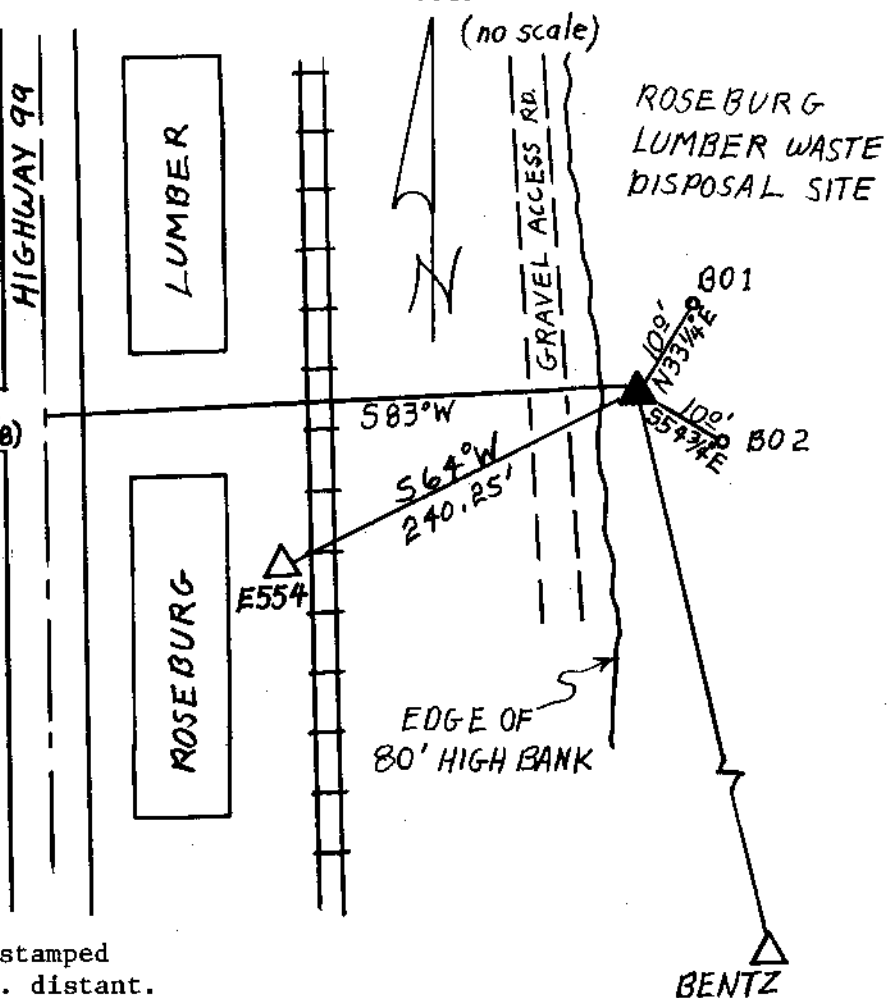
SKETCH

A 1 3/4 inch diameter by 34 inch long steel rod stamped "HUB A 1984" (stamping faces West) protrudes 1 inch above ground.

A 5/8 inch iron rod with aluminum cap stamped "BO 1 1984" bears N 33 1/4° E, 10.0 ft. distant.

A 5/8 inch iron rod with aluminum cap stamped "BO 2 1984" bears S 54 3/4° E, 10.0 ft. distant.

From the intersection of Patchen Drive and State Highway 99 in Dillard (T28S, R6W, Sec. 29) proceed easterly along Patchen Drive approx. 100 ft. to a private Roseburg Lumber road on the right, proceed southerly along Roseburg Lumber road approx. 0.3-miles to a gravel road on left, DYKE RD. (CORR. #158) proceed easterly along gravel road approx. 200 ft. to a rock quarry, proceed north-
POST OFFICE
erly from rock quarry approx. 0.2 mile along a road to Roseburg Lumber waste disposal site. Monument is to left near edge at top of an 80 ft. high cut bank.
