OFFICE OF THE  
DOUGLAS COUNTY SURVEYOR

Station: M76

M-076  
M76

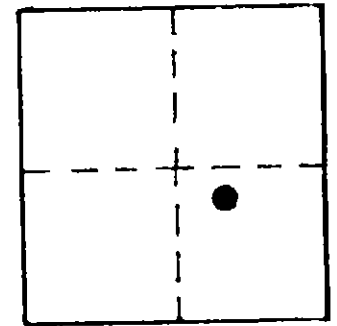
SKETCH

Found: A standard DCSO disk stamped "M76 1991".  
set in concrete curb.

To Reach: At the intersection of North Myrtle Rd.  
(Co. Rd. #15) and Madrona St. in Myrtle  
Creek.
