OFFICE OF THE  
DOUGLAS COUNTY SURVEYOR

Station: X-032

T 27 S, R 2W , Sec 9

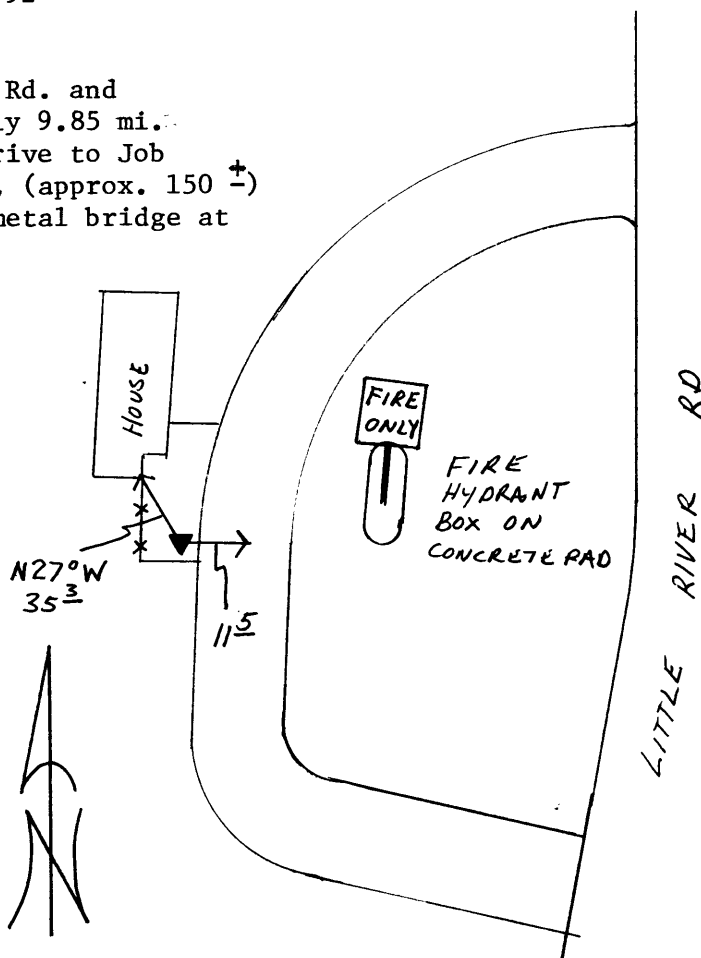
SKETCH

Set: A standard DCSO disk stamped "X-032 1992"  
set in a concrete driveway.

To Reach: From the intersection of Buckhorn Rd. and  
Litter River Rd. proceed N'Easterly 9.85 mi.  
(MP 21.35) to intersection with drive to Job  
Corp housing which is the 1st. Rd. (approx. 150 ±)  
to the left beyond arched green metal bridge at  
Wolf Creek Trailhead. See sketch.
