OFFICE OF THE  
DOUGLAS COUNTY SURVEYOR

Station: SOUCI, T 27 S, R 6 W, Sec 16  
Set By (Agency): DCSO  
Date Set: 1989  
Recovered By RWS,SJF  
Date Recovered 5/11/89  
Recovered By \_\_\_\_\_  
Date Recovered \_\_\_\_\_  
Recovered By \_\_\_\_\_  
Date Recovered \_\_\_\_\_

S-163

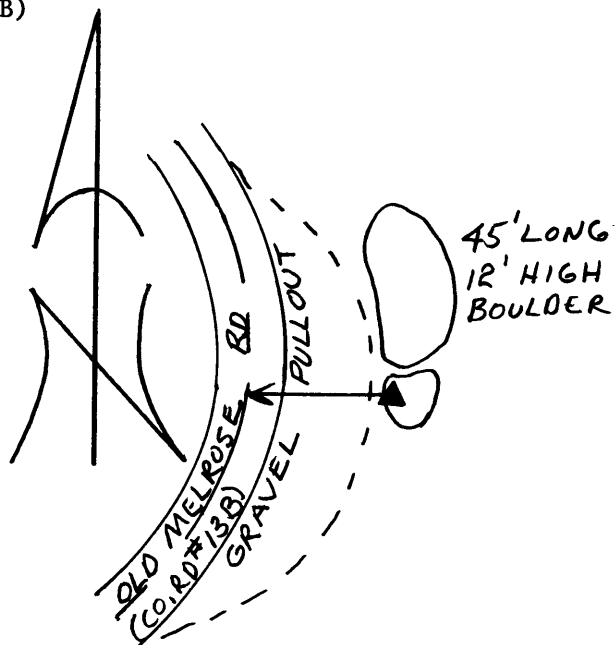
SKETCH

A DCSO disk stamped "SOUCI 1989" set near west edge of a 5 ft. by 6 ft. by 4 ft. high boulder, disk is 3 ft. above ground.

From the intersection of Old Melrose Rd. (Co.Rd.#13B) and San Souci Dr. (Co.Rd.#326A) in T27S,R6W,Sec.16, proceed southeasterly along Old Melrose Rd. approx. 0.15 miles to a sharp right hand curve, monument is on left.
