OFFICE OF THE  
DOUGLAS COUNTY SURVEYOR

Station: VALLEY T 27 S, R 6 W, Sec 28  
Set By (Agency): DCSO  
Date Set: 1989  
Recovered By RWS, SJF  
Date Recovered 6/1/89  
Recovered By \_\_\_\_\_  
Date Recovered \_\_\_\_\_  
Recovered By \_\_\_\_\_  
Date Recovered \_\_\_\_\_

V-029

VERTICAL CONTROL **NGVD 29**

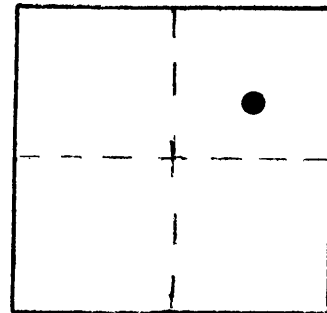
SKETCH

A DCSO drill cap stamped "VALLEY 1989" set in a 4 ft. by 4 ft. concrete pad supporting southerly end of Diamond Valley subdivision entrance sign.

From the intersection of Military ave. (Co.Rd.#113) and Lookingglass Rd. (Co.Rd.#5D) in T27S,R6W,Sec.22, proceed southwesterly along Lookingglass Rd. approx. 0.9 miles to Topaz lane and monument on right.
