OFFICE OF THE  
DOUGLAS COUNTY SURVEYOR

Station: PIT T 27 S, R 6 W, Sec 29  
Set By (Agency): DCSO  
Date Set: 1989  
Recovered By RWS, SJF  
Date Recovered 6/1/89  
Recovered By \_\_\_\_\_  
Date Recovered \_\_\_\_\_  
Recovered By \_\_\_\_\_  
Date Recovered \_\_\_\_\_

VERTICAL CONTROL NGVD 29

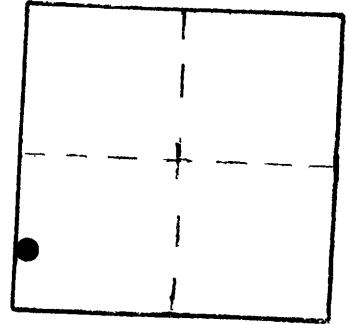
SKETCH

A DCSO disk stamped "PIT 1989" set in an 8 in. dia. by 42 in. long concrete filled belltile flush with ground.

From the intersection of Lookingglass Rd. (Co.Rd.#5D) and Nandy Rd. (Co.Rd.#336) in T27S,R7W,Sec.25, proceed northeasterly along Lookingglass Rd. 1.35 miles to monument on right.
