OFFICE OF THE  
DOUGLAS COUNTY SURVEYOR

Station: Y 749  
Date Set: 1987  
Set By (Agency): NGS  
DCSO Designation: Y-025  
Date Recovered: 8-93  
Recovered By: RWS SJF  
Date Recovered: \_\_\_\_\_  
Recovered By: \_\_\_\_\_  
Date Recovered: \_\_\_\_\_  
Recovered By: \_\_\_\_\_

T28W R6W Sec.15

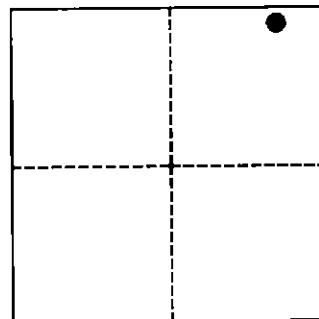
Found: A 9/16 inch diameter stainless steel rod set under a 6 - 5/8 inch diameter aluminum collar and access cover set in concrete and flush with ground. The rim of the access cover collar is stamped "Y 749 1987".

To reach: From the intersection of Carnes Rd. (Co. Rd. #16) and State Hwy 99 and 42 in T28S R6W Sec11 proceed southerly along State Hwy 42 and 99 0.50 miles to monument on left.
