OFFICE OF THE  
DOUGLAS COUNTY SURVEYOR

Station: MORGAN \* **DISTURBED** \*  
 Date Set: 1972  
 Set By (Agency): GARRET LS #0544  
 DCSD Designation: M-054  
 Date Recovered: 10-22-1984  
 Recovered By: RS SJF  
 Date Recovered: \_\_\_\_\_  
 Recovered By: \_\_\_\_\_  
 Date Recovered: \_\_\_\_\_  
 Recovered By: \_\_\_\_\_

T28W R6W Sec. 16

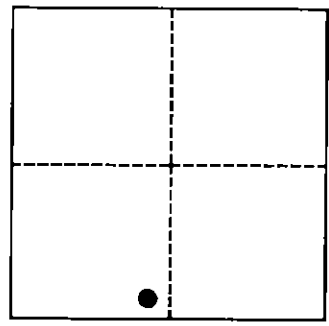
**NOTE \* MON. IS DISTURBED \***

Description: A DCSD disk stamped "MORGAN 1972" set on an iron pipe protruding 2 inches above the ground.

\*NOTE: MONUMENT IS IN PLOWED FIELD AND HAS BEEN DISTURBED (CAP SHOWS SCUFF MARKS)

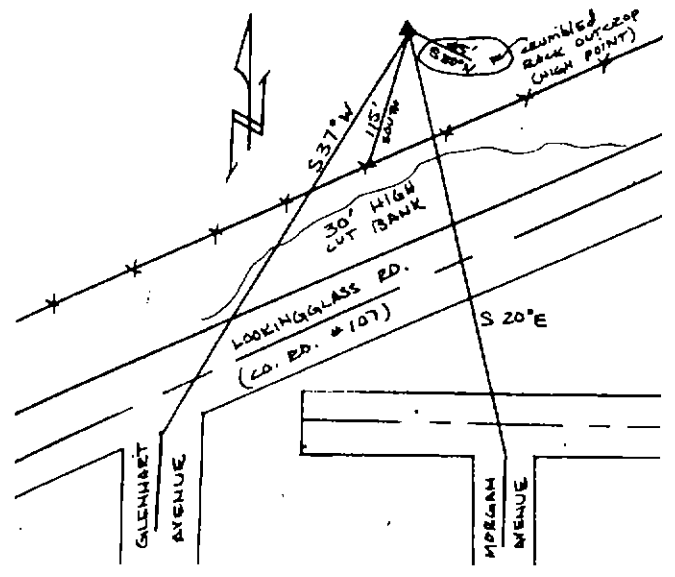
To reach: From the intersection of State Hwy 99 and Lookingglass Rd. (Co. Rd. #107) in T28S R6W Sec16 proceed westerly along Lookingglass Rd. approx. 0.3 miles to monument approx. 150 feet on right.
