OFFICE OF THE
DOUGLAS COUNTY SURVEYOR

Station: BARK
 Date Set: 1990
 Set By (Agency): DCSO
 Date Recovered: 3/8/91
 Recovered By: SJF - TF
 Date Recovered: _____
 Recovered By: _____
 Date Recovered: _____
 Recovered By: _____

DESIG. **B-124**

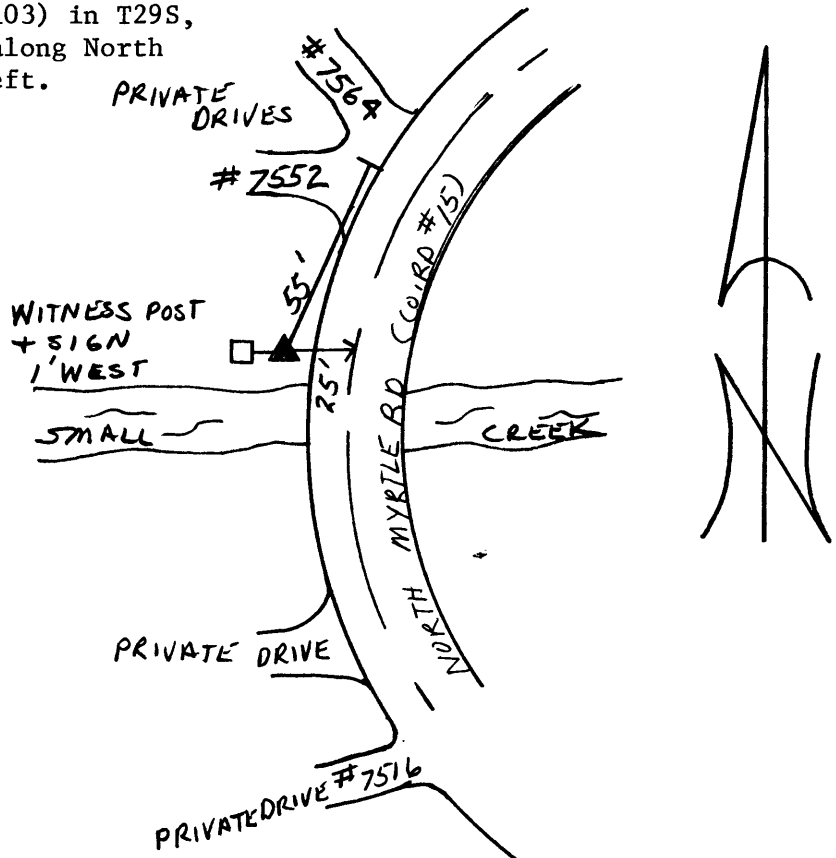
SKETCH

A standard DCSO disk stamped "BARK 1990" set in a 8" x 40" concrete filled belltile protruding 2" above ground. ;

From the intersection of North Myrtle Rd. (Co. Rd. #15) and Bilger Creek Rd. (Co. Rd. #103) in T29S, R5W, sec. 14 proceed northeasterly along North Myrtle Rd. 4.65 mi. to mon. on the left.
