OFFICE OF THE  
DOUGLAS COUNTY SURVEYOR

M-093

Station: McMiller  
 Date Set: 1990  
 Set By (Agency): DCSO  
 Date Recovered: 1/18/91  
 Recovered By: SJE, TF  
 Date Recovered: FDOK 1/9/01  
 Recovered By: \_\_\_\_\_  
 Date Recovered: \_\_\_\_\_  
 Recovered By: \_\_\_\_\_

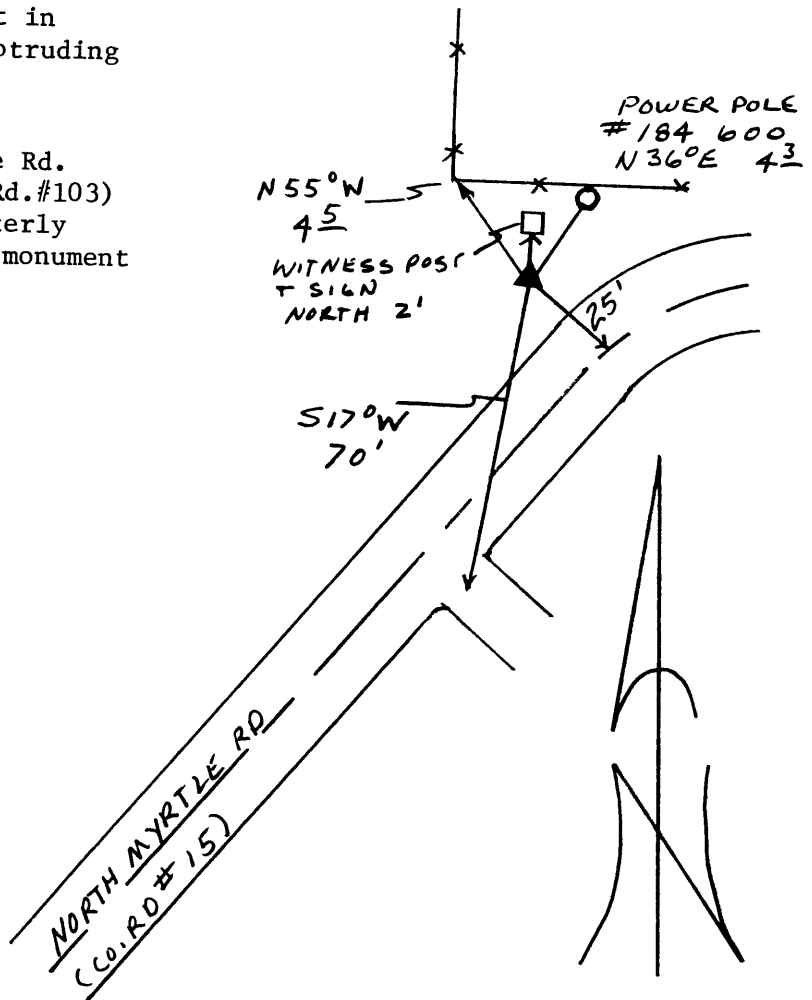
SKETCH

A DCSO disk stamped "**McMILLER** 1990" set in a 8"x40" concrete filled belltile protruding 4" above ground.

From the intersection of North Myrtle Rd. (Co.Rd.#15) and Bilger Creek Rd. (Co.Rd.#103) in T29S,R5W,Sec.22, proceed northeasterly along North Myrtle Rd. 2.15 miles to monument on left.
