DOUGLAS COUNTY SURVEYOR'S OFFICE

Designation: 90-163 Station: 10+00BOP T 27S R 6W S 14 $\frac{1}{4}$ NE

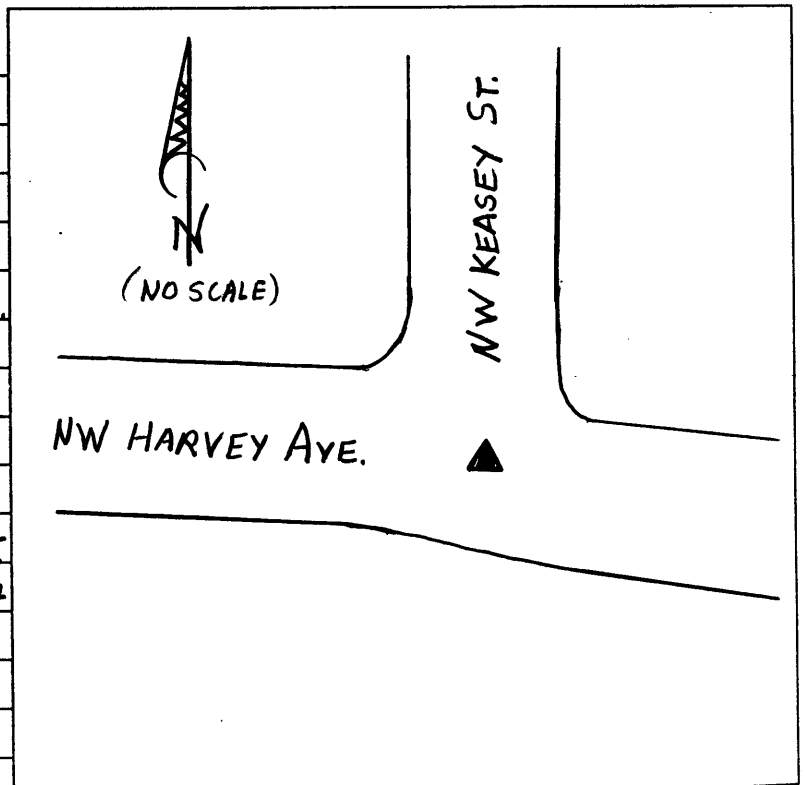
A 2 5/8 INCH DIAM. BRASS CAP,
STAMPED "AA SURVEYING INC.", ON
A 1 1/2 X 36 INCH GALV. IRON PIPE,
SET BELOW ASPHALT ROAD SUR-
FACE, UNDER AN 11 1/2 INCH DIAM.
CAST IRON MONUMENT COLLAR
AND COVER.

GO TO THE INTERSECTION OF
NW HARVEY AVE. AND NW KEASEY ST.
IN THE NE QUARTER OF SECTION 14
T27S, R6W. MONUMENT FALLS
NEAR THE CENTER OF THE INTER-
SECTION OF THE TWO STREETS.
