DOUGLAS COUNTY SURVEYOR'S OFFICE

Designation: 90-164 Station: 16+32.78 T 27S R 6W S 14 1/4 NE

DESCRIPTION AND TO REACH

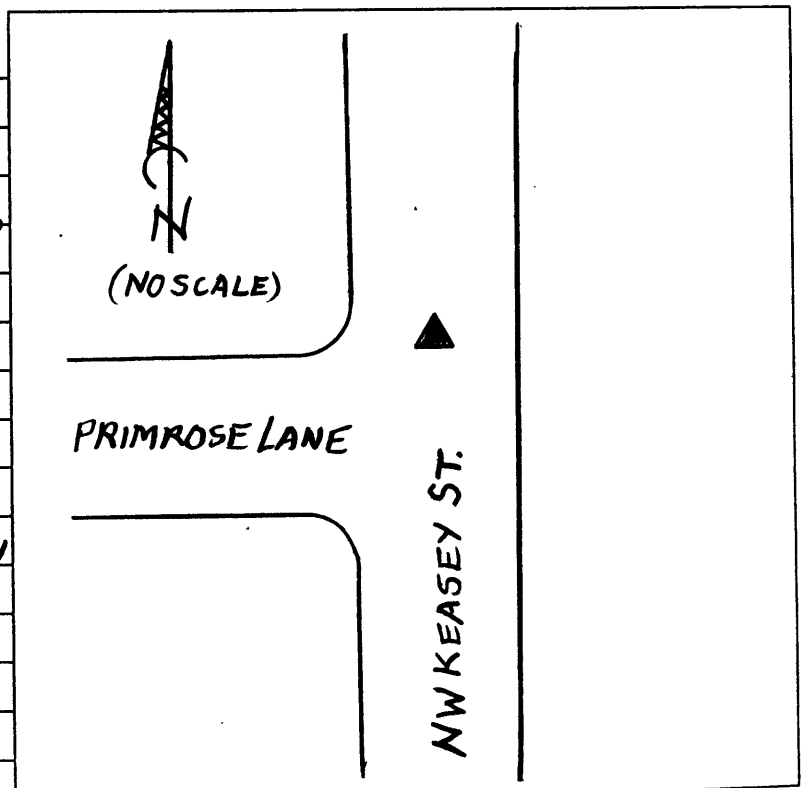
A 2 5/8 INCH DIAM. BRASS CAP
STAMPED "AA SURVEYING INC", ON
A 1 1/2 x 36 INCH GALV. IRON PIPE,
SET BELOW ASPHALT ROAD SUR-
FACE, UNDER A 7 INCH DIAM.
ALUMINUM MONUMENT COLLAR
AND COVER.

GO TO THE INTERSECTION OF
PRIMROSE LANE AND NW KEASEY
ST. IN THE NE QUARTER OF
SECTION 14, T27S, R6W. MON-
UMENT FALLS JUST NORTH
OF THE ABOVE INTERSECTION
NEAR THE ♀ OF NW KEASEY ST.
