DOUGLAS COUNTY SURVEYOR'S OFFICE

Designation: 90-165 Station: 21+87.37 T 27S R 6W S 14 1/4 NE

Date Recovered: 9/08 Recovered by: SJF

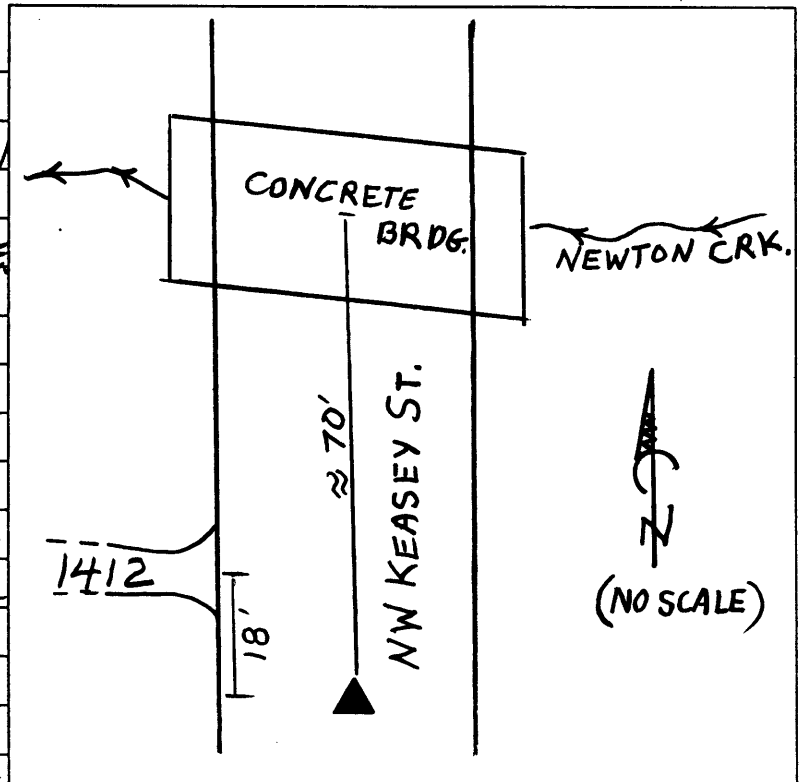
PHOTO FILE NAME

A 2 3/8 INCH DIAM. BRASS CAP
STAMPED "AA SURVEYING INC", ON
A 1 1/2 X 36 INCH GALV. IRON PIPE,
SET BELOW ASPHALT ROAD SURFACE
UNDER AN 11 1/2 INCH DIAM. CAST-
IRON MONUMENT COLLAR AND
COVER.

FROM THE INTERSECTION OF
PRIMROSE LANE AND N.W. KEASEY
AVE. IN THE NE QUARTER OF SEC-
TION 14, T 27S, R 6W, PROCEED
NORTH ALONG KEASEY APPROX.
0.1 MILES TO A POINT NEAR ♀
OF RD. AND ≈ 70 FT. SOUTH OF NEWTON CRK.
