**DOUGLAS COUNTY SURVEYOR'S OFFICE**

Designation: 70-167 Station: 32+17.80 T 27S R 6W S 14  $\frac{1}{4}$  NE

Date Recovered: 9/08 Recovered by: SJF

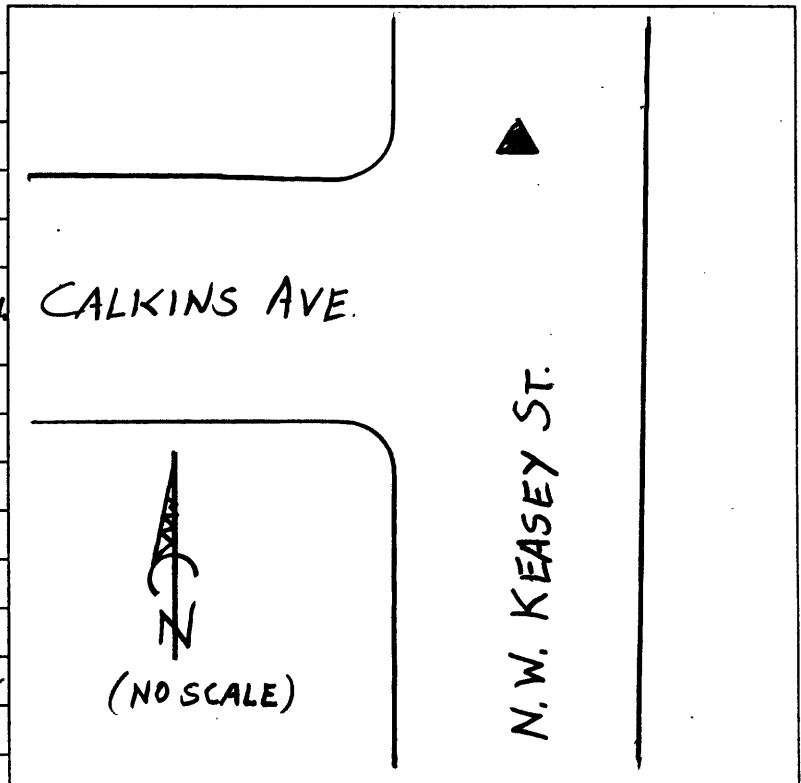
A 2 5/8 INCH DIAM. BRASS CAP  
STAMPED "AA SURVEYING INC." ON  
A 1 1/2 x 36 INCH GALV. IRON PIPE,  
SET BELOW ASPHALT ROAD  
SURFACE UNDER AN 11 1/2 INCH DIAM  
CAST-IRON MONUMENT COLLAR  
AND COVER.

GO TO THE INTERSECTION OF  
N.W. KEASEY ST. AND CALKINS  
AVE. IN THE N.E. QUARTER OF  
SECTION 14, T27S, R6W. MONU-  
MENT FALLS JUST NORTH OF THE  
ABOVE INTERSECTION NEAR THE  
☐ OF N.W. KEASEY ST.
