NE1/4 SECTION 21, T.28S., R.6W., W.M.

OREGON DEPARTMENT OF TRANSPORTATION
 HORIZONTAL CONTROL, RECOVERY AND RETRACEMENT MAP
 OR42: LOOKINGGLASS CREEK
 TO I-5 (WINSTON) SECTION
 COOS BAY - ROSEBURG HIGHWAY
 DOUGLAS COUNTY

ODOT REGION 3 TECH CENTER
 3500 NW STEWART PKWY.
 ROSEBURG, OR 97470 KEY NO. K21677

OCTOBER 30, 2024
 SCALE: 1" = 50'
 SHEET 6 OF 7

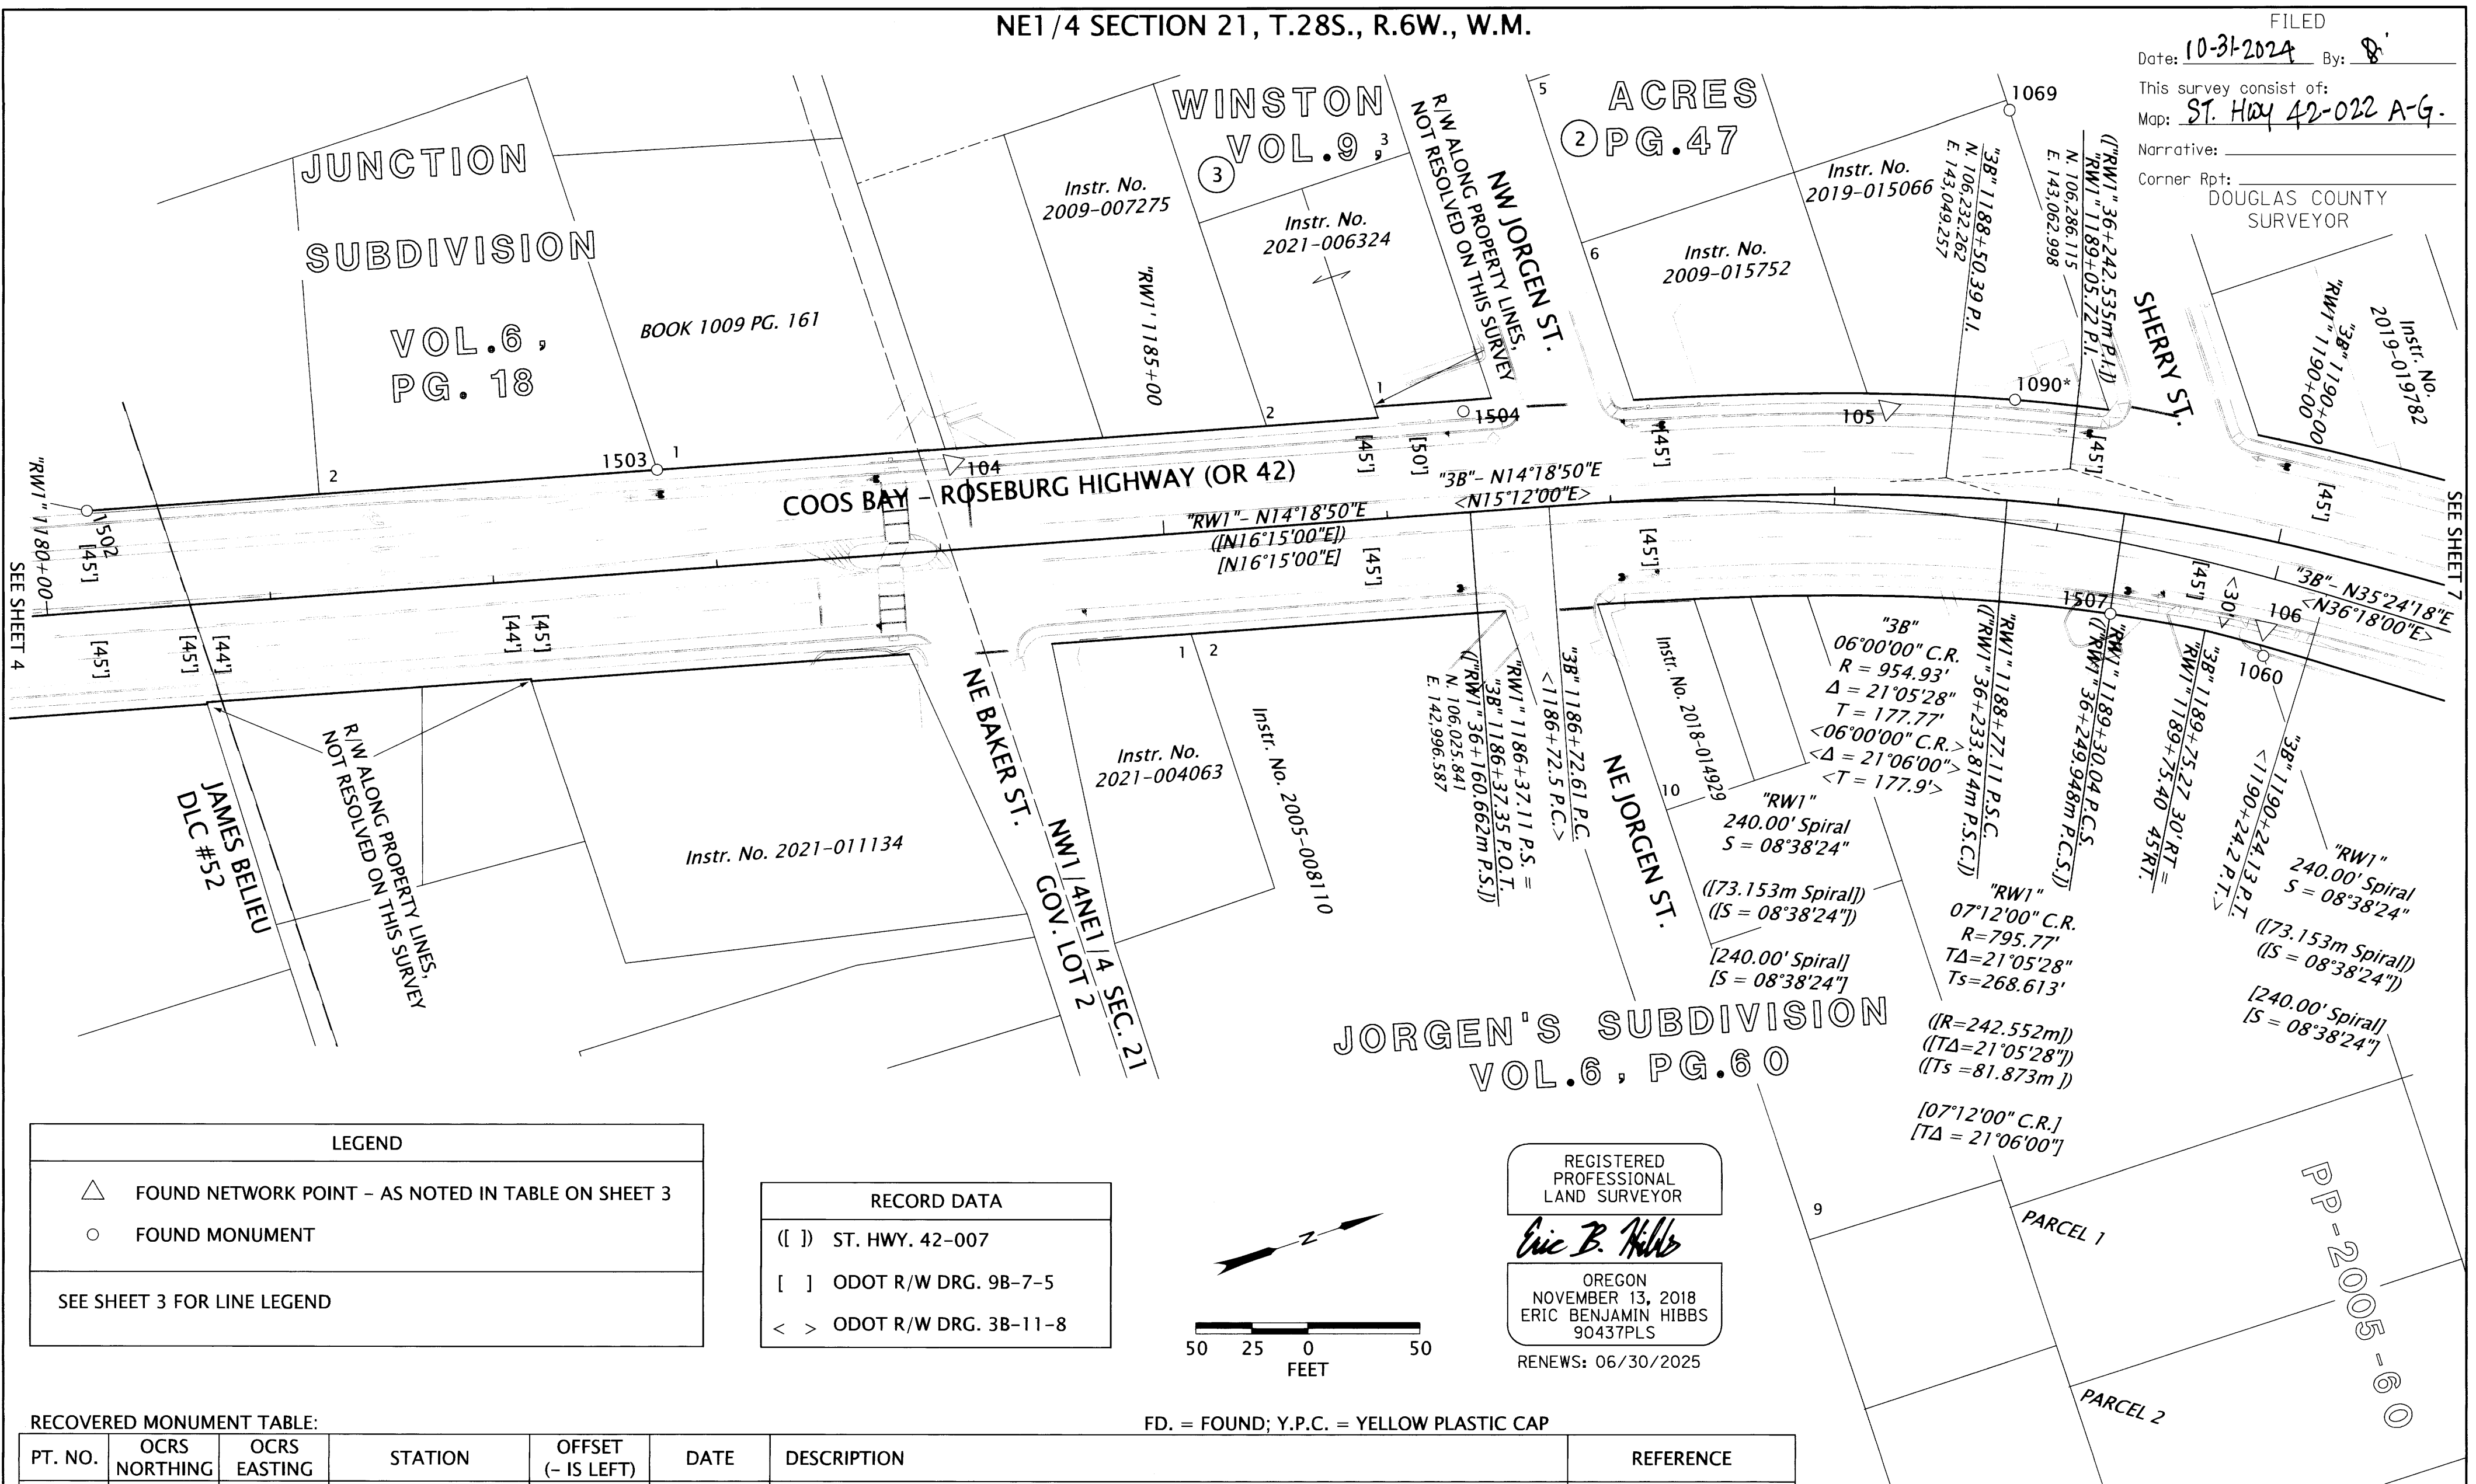
LEGEND	
△	FOUND NETWORK POINT - AS NOTED IN TABLE ON SHEET 3
○	FOUND MONUMENT
SEE SHEET 3 FOR LINE LEGEND

PT. NO.	OCRS NORTHING	OCRS EASTING	STATION	OFFSET (- IS LEFT)	DATE	DESCRIPTION	REFERENCE
1060	106341.60	143169.33	"3B" 1190+04.33	34.32'	10/28/2021	FD. 5/8" REBAR WITH REMNANT OF Y.P.C., FLUSH IN ASPHALT, FAIR CONDITION	1993-0104A
1069	106310.89	142903.48	-	-	10/13/2022	FD. 5/8" REBAR, FLUSH, GOOD CONDITION	UNKNOWN
1090*	106272.50	143026.05	"RW1" 1188+77.18	45.00	-	FD 5/8" IRON REBAR	DRG. 9B-7-5
1502	105439.97	142800.63	"RW1" 1180+20.97	-45.03	9/17/2024	FD. 1-1/2" ALUMINUM. CAP STAMPED "OREG. STATE HWY. DIV." IN GOOD CONDITION, 0.05' BELOW GROUND	DRG. 9B-7-5
1503	105687.37	142863.77	"RW1" 1182+76.31	-45.01	9/17/2024	FD. 5/8" IRON REBAR IN GOOD CONDITION, 0.10' BELOW GROUND	M71-26
1504	106037.10	142953.01	"RW1" 1186+37.24	-45.01	9/17/2024	FD. 1-1/2" ALUMINUM. CAP STAMPED "OREG. STATE HWY. DIV." IN GOOD CONDITION, FLUSH IN PAVED SLOPE	DRG. 9B-7-5
1507	106282.76	143129.94	"RW1" 1189+30.18	44.99	9/17/2024	FD. 1-1/2" ALUMINUM. CAP STAMPED "OREG. STATE HWY. DIV. 1189+30.29 PCS 45.0 RT" IN GOOD CONDITION, FLUSH IN GROUND	DRG. 9B-7-5
