MAP OF SURVEY

LOCATED in the SE 1/4 of Section 13, T. 22 S., R. 5 W., W.M.
in Douglas County, Oregon.

SURVEYED FOR: *NANCY BENZEL*
BOSWELL ROAD
YONCALLA, OREGON

SURVEYED BY: *DAVID EDWARDS LAND SURVEYING*
P.O. BOX 361
OAKLAND, OREGON 97462
PHONE: (541) 459-0512

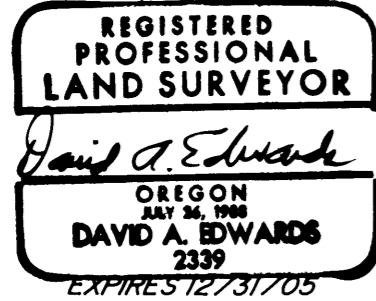
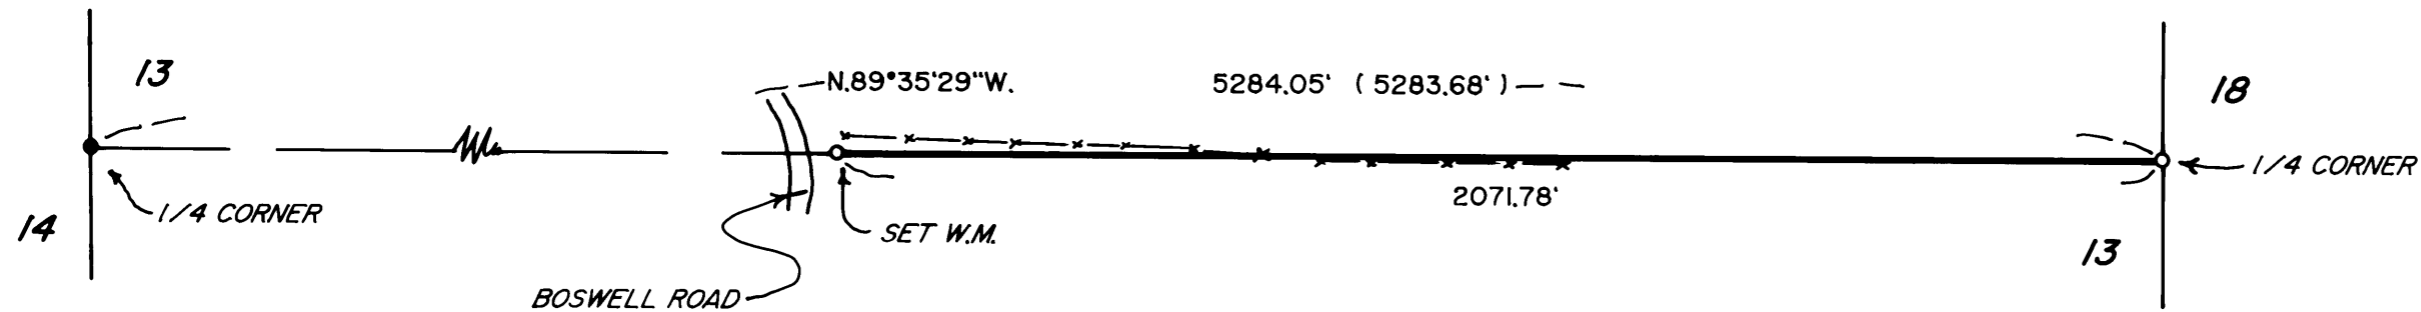
MAP FILE M144-6

THE PURPOSE OF THIS SURVEY IS TO MARK THAT PORTION OF THE EAST-WEST CENTERLINE OF SECTION 13 DEPICTED AS A BOLD LINE HEREON. THE LINE WAS MARKED BY BLAZING TREES ON EACH SIDE OF LINE, BY SETTING 6 FOOT STEEL POSTS ALONG LINE AT APPROXIMATELY 200 FOOT INTERVALS AND BY HANGING RED FLAGGING ALONG THE LINE. THE BRASS CAPPED IRON PIPE WHICH WAS MONUMENTING THE EAST 1/4 CORNER HAS BEEN HIT BY A BULLDOZER AND IS BADLY DAMAGED AND BENT OVER. I SET MY PIN AND CAP AT RECORD POSITION FROM THE TWO BEARING TREES NOTED ON M 129-46.
