RECORD OF SURVEY

"ELK EA CADASTRAL SURVEY"
 USDA FOREST SERVICE
 UMPQUA NATIONAL FOREST
 TILLER RANGER DISTRICT
 CONTRACT NO. AG-04H1-C-14-0008
 TASK ORDER NO. 1204T018F0072
 LOCATED IN
 SECTION 5, T.32S., R.1W., W.M.
 DOUGLAS COUNTY, OREGON

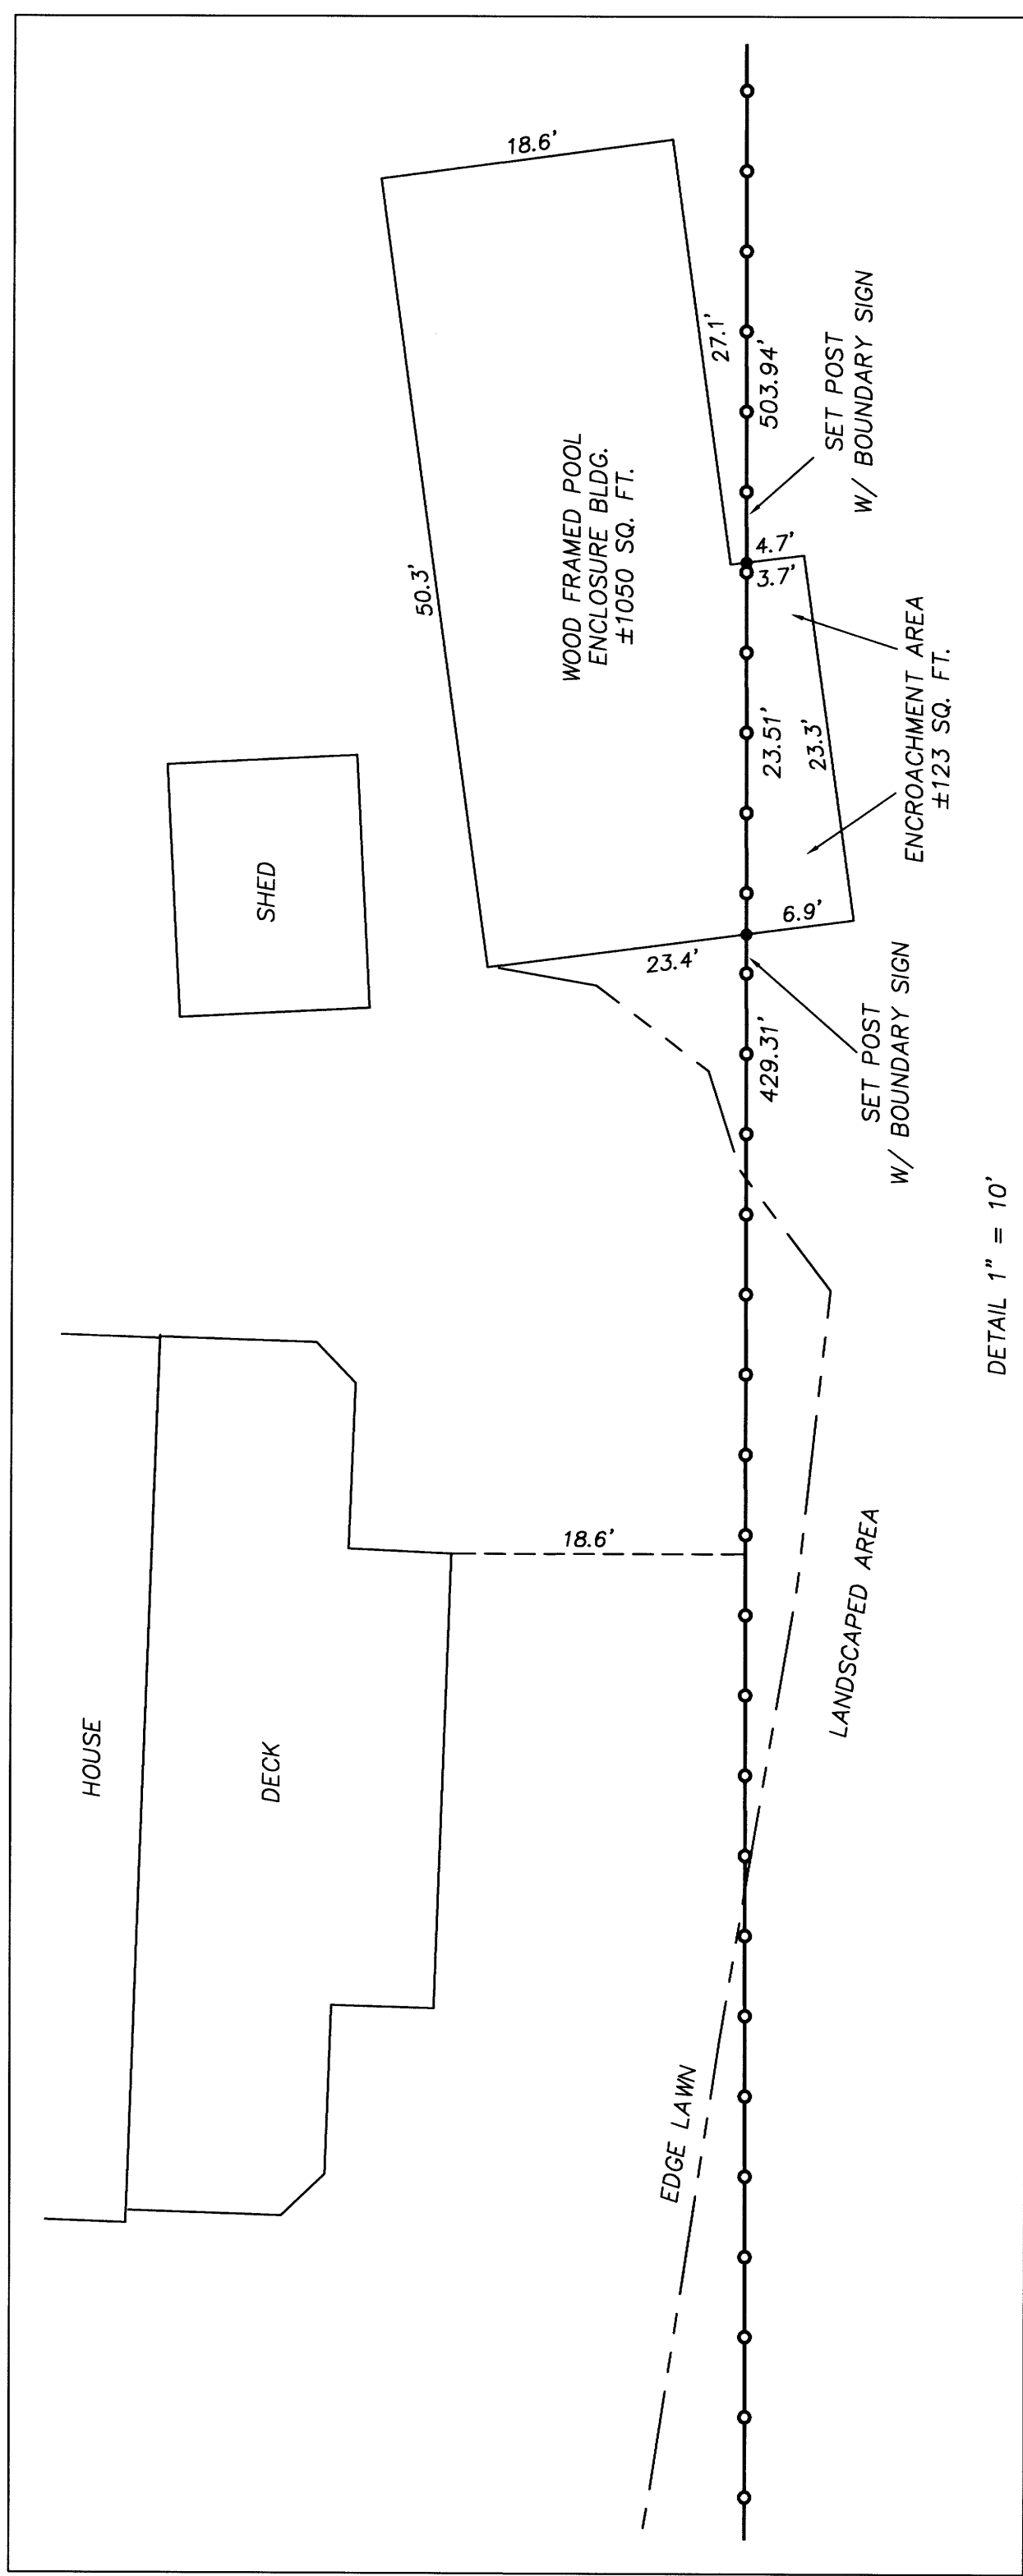
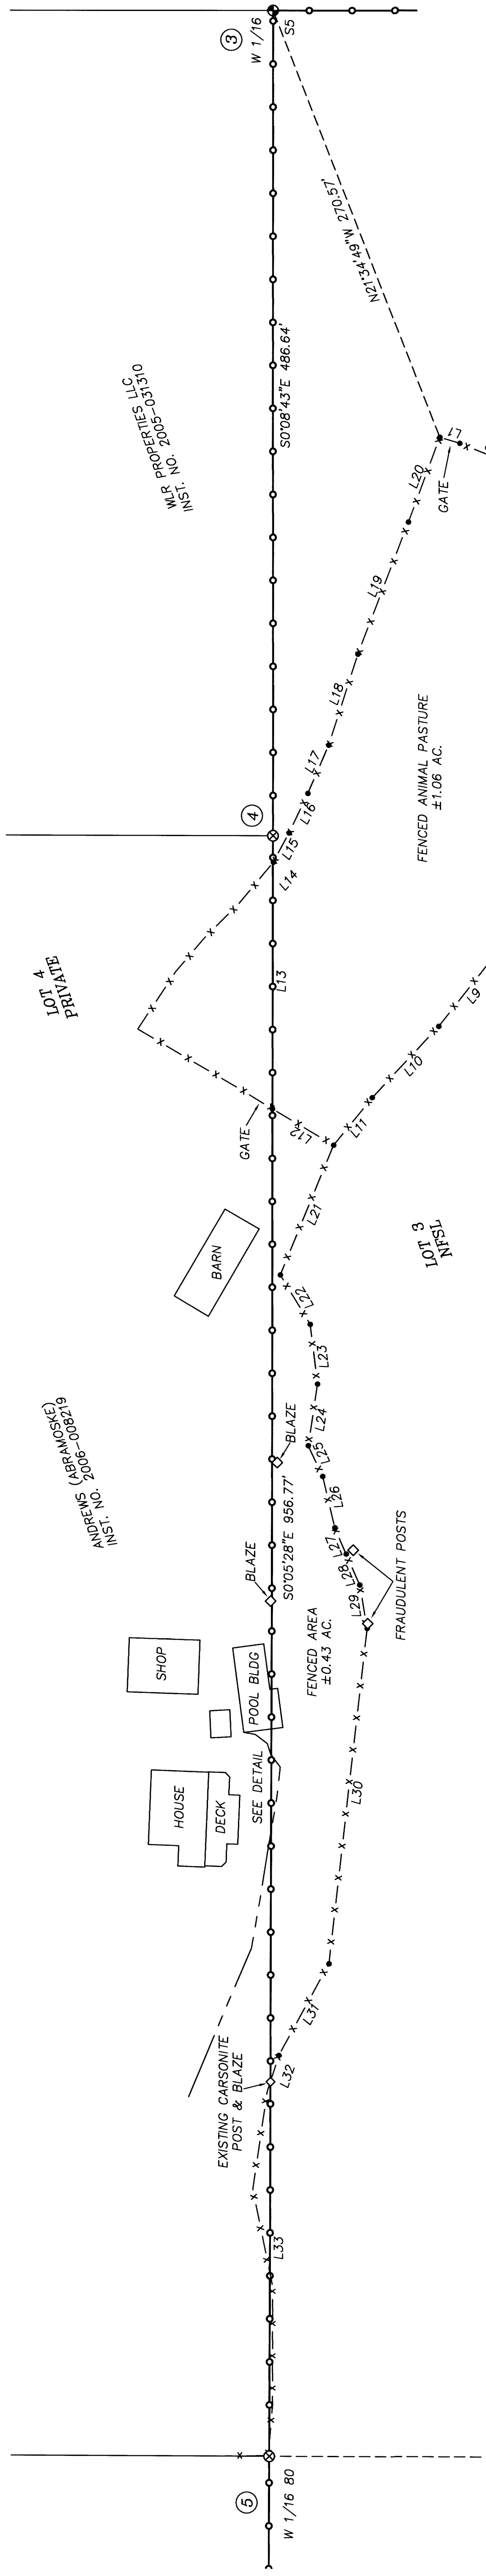
ENCROACHMENT NOTES:
 ALONG THE WEST BOUNDARY OF LOT 3 WITH ANDREWS (ABRAMOSKE), I FIND EVIDENCE THAT THE POSTS SET BY SHANER PER RM 3-37, OR RECOVERED AND SET BY THE 1994 USFS LINE MAINTENANCE WORK, APPEAR TO HAVE BEEN FRAUDULENTLY MOVED FROM THE TRUE BOUNDARY LINE. I FIND AN ALUMINUM POST 48.1 FEET EAST OF THE TRUE BOUNDARY LINE. I FIND 16 OF THESE ALUMINUM POSTS, 16 OF WHICH WERE SET BY JERRY ANDREWS PERSONALLY, STATED TO ME THAT THESE POSTS WERE IN THE SAME AREA AS THE TRUE BOUNDARY LINE. ANDREWS PURCHASED THE PROPERTY IN 2006. I ALSO FIND HEALED BLAZES IN THE SAME AREA ON THE TRUE LINE. ANDREWS CONSTRUCTED THE 8 FOOT HIGH LIGHT DUTY DEER FENCE TO THESE FRAUDULENT POSTS. THE FENCE COMES BACK ONTO LINE SOUTH OF THE HOUSE AT AN EXISTING CARSONITE POST AND BLAZED TREE PORTIONS OF LAWN AND LANDSCAPING ARE MAINTAINED EAST OF THE BOUNDARY.
 THE NORTHERLY FENCED ANIMAL PASTURE APPEARS TO BE FENCED IN THE SAME LOCATION AS MAPPED IN 1980 UNDER RM 5-37.

THE EASTERLY WALL OF THE WOOD FRAMED POOL ENCLOSURE IS CONSTRUCTED OVER THE N.F. BOUNDARY LINE, AS SHOWN IN THE DETAIL. POSTS WITH N.F. BOUNDARY SIGNS ARE SET NORTH AND SOUTH OF THE BUILDING ON THE BOUNDARY.
 THE FENCES WERE TIED AT THEIR ANGLE POINTS AND THEIR COURSES LISTED IN THE LINE TABLE.
