RECORD OF SURVEY

LOCATED IN A PORTION OF
GOV'T LOTS 1, 2, 3, 4 AND
THE NW 1/4, NE 1/4, SE 1/4, SW 1/4
OF SECTION 5 AND THE NE 1/4 OF SECTION 7
T. 31 S., R. 8 W., W.M., AND IN A PORTION OF
THE NE 1/4 OF SECTION 1, T. 31 S., R. 9 W., W.M.
SNAKE EYES 2-TASK H
DOUGLAS COUNTY, OREGON
CONTRACT NO. 1204T020D0010
TASK ORDER NO. 140L4322F0063

SURVEY FOR: UNITED STATES DEPARTMENT OF THE INTERIOR BUREAU OF LAND MANAGEMENT
ROSEBURG DISTRICT OFFICE
777 NW GARDEN VALLEY BLVD
ROSEBURG, OR 97471

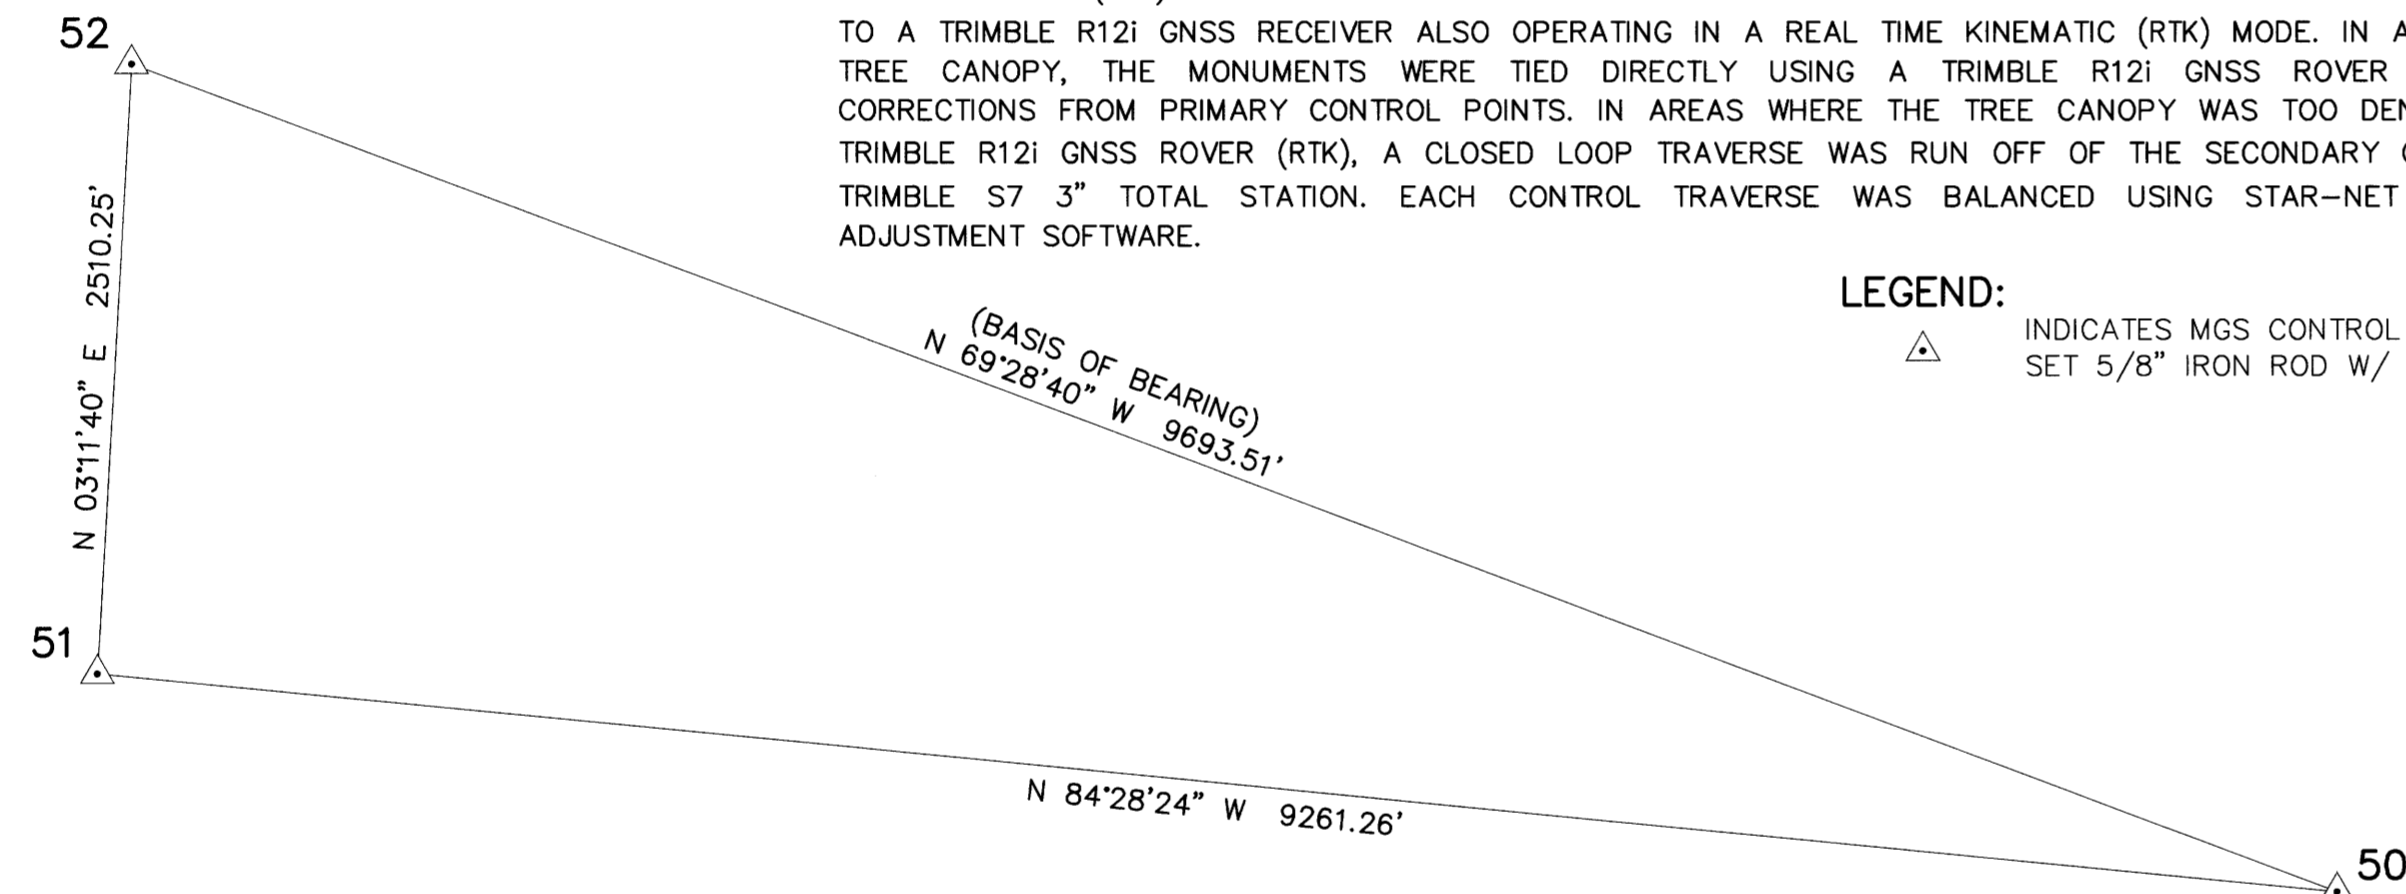
CONTROL PROCEDURE:

A TRIMBLE R12 GNSS BASE RECEIVER WAS USED TO COLLECT OVER 8 HOURS OF STATIC DATA ON THE PRIMARY CONTROL POINTS 50, 51 & 52. THE STATIC DATA WAS THEN POST PROCESSED USING THE NATIONAL GEODETIC SURVEY ONLINE POSITIONING USER SERVICE (OPUS).

THE SECONDARY CONTROL WAS ESTABLISHED BY USING A TRIMBLE R12 GNSS BASE RECEIVER OPERATING IN A REAL TIME KINEMATIC (RTK) MODE AND SET ON THE PRIMARY OPUS CONTROL WHILE TRANSMITTING REAL TIME CORRECTIONS TO A TRIMBLE R12I GNSS RECEIVER ALSO OPERATING IN A REAL TIME KINEMATIC (RTK) MODE. IN AREAS OF MINIMAL TREE CANOPY, THE MONUMENTS WERE TIED DIRECTLY USING A TRIMBLE R12I GNSS ROVER WHILE RECEIVING CORRECTIONS FROM PRIMARY CONTROL POINTS. IN AREAS WHERE THE TREE CANOPY WAS TOO DENSE FOR USING A TRIMBLE R12I GNSS ROVER (RTK), A CLOSED LOOP TRAVERSE WAS RUN OFF OF THE SECONDARY CONTROL USING A TRIMBLE S7 3" TOTAL STATION. EACH CONTROL TRAVERSE WAS BALANCED USING STAR-NET LEAST SQUARES ADJUSTMENT SOFTWARE.

POINT NO.	NORTHING	EASTING	ELEV	DESCRIPTION
50	24467.85	74297.64	2584.57	5/8" IRON ROD W/ 2" ALUM. CAP "SNAKE-1 2023"
51	25359.78	65079.43	2640.69	5/8" IRON ROD W/ 2" ALUM. CAP "SNAKE-2 2023"
52	27866.13	65219.32	2265.00	5/8" IRON ROD W/ 2" ALUM. CAP "SNAKE-3 2023"

BASIS OF BEARING: N 69°28'40" W ALONG THE CONTROL LINE BETWEEN (MGS CONTROL POINT 50) AND (MGS CONTROL POINT 52) OREGON COORDINATE REFERENCE SYSTEM (OCRS), COTTAGE GROVE-CANYONVILLE ZONE, INTERNATIONAL FEET.
