DOUGLAS COUNTY
 SURVEYOR

MAP FILE M186-1B

SHEET 2 OF 2

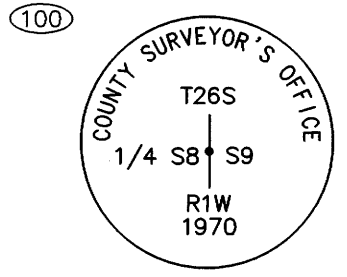
PLSS 300540
 FOUND AND HELD AN IRON PIPE, 1" DIAMETER, WITH A 2 1/2" BRASS CAP, SET PER R(1), AND ACCEPTED ON R(2) AND ON R(3).
 FROM WHICH FOUND DEAD, STANDING, AND FIRE DAMAGED BEARING TREES MEASURE:
 R(GLO):
 30" DOUGLAS FIR, BEARS N41°26'W, 32.00' (R(GLO): N41°W, 33.00').
 R(1): 14" DOUGLAS FIR, BEARS S12°04'E, 12.50' (RECORDS: R(1) AND R(2) S19°E; AND R(3) S17°E, 11.5').
 9" DOUGLAS FIR, BEARS N72°44'W, 6.70' (RECORDS: R(1), R(2), AND R(3) N65°W).
 SET TWO REFERENCE MONUMENTS - REBAR, 5/8 INCH DIAMETER, 30 INCHES LONG, WITH A YELLOW PLASTIC CAP MARKED S&F LAND SERVICES : BEARING S40°16'20"E, 10.80' AND N35°39'13"W, 7.81'.

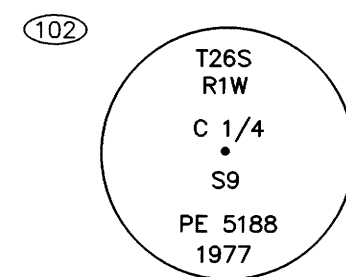
PLSS 340540
 FOUND AND HELD AN IRON PIPE, 1" DIAMETER, WITH A 2 1/2" BRASS CAP, SET PER R(2).
 FROM WHICH FOUND DEAD, FIRE DAMAGED BEARING TREES MEASURE:
 R(2): 38" DOUGLAS FIR, BEARS S85°00'00"E, 7.0'.
 18" DOUGLAS FIR, BEARS N63°00'00"W, 9.0'.
 SET FOUR REFERENCE MONUMENTS - REBAR, 5/8 INCH DIAMETER, 30 INCHES LONG, WITH A YELLOW PLASTIC CAP MARKED S&F LAND SERVICES:
 BEARING N46°03'49"E, 3.77', S26°07'09"E, 6.15', S57°13'30"W, 5.80', AND N41°38'17"W, 6.27'.

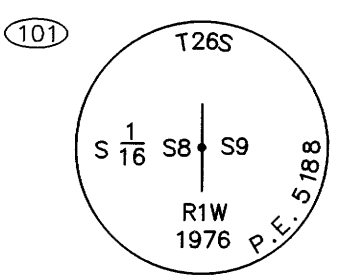
PLSS 300520
 FOUND AND HELD AN IRON PIPE, 1" DIAMETER, WITH A 2 1/2" BRASS CAP, SET PER R(2).
 FROM WHICH FOUND DEAD, FIRE DAMAGED BEARING TREES MEASURE:
 R(2): 34" DOUGLAS FIR, BEARS S26°11'29"E, 23.12'
 (R(2): S25°E, 21.4').
 18" DOUGLAS FIR, BEARS S37°04'27"W, 24.22'
 (R(2): S35°15'W, 24.2').
 SET TWO REFERENCE MONUMENTS - REBAR, 5/8 INCH DIAMETER, 30 INCHES LONG, WITH A YELLOW PLASTIC CAP MARKED S&F LAND SERVICES : BEARING S9°09'31"E, 15.63' AND S76°33'54"W, 10.77'.

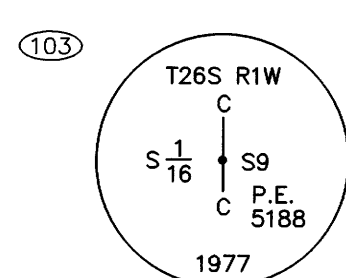
PLSS 340520
 FOUND AND HELD AN IRON PIPE, 1" DIAMETER, WITH A 2 1/2" BRASS CAP, SET PER R(2).
 (NOTE: NEITHER OF THE BEARING TREES ON R(2) WERE RECOVERED).
 SET TWO REFERENCE MONUMENTS - REBAR, 5/8 INCH DIAMETER, 30 INCHES LONG, WITH A YELLOW PLASTIC CAP MARKED S&F LAND SERVICES : BEARING N50°42'38"E, 10.15' AND S24°31'31"W, 12.00'.
